dsPIC33FJ06GS101/X02 and dsPIC33FJ16GSX02/X04

dsPIC33FJ06GS101/X02 and dsPIC33FJ16GSX02/X04 Family Silicon Errata and Data Sheet Clarification

The dsPIC33FJ06GS101/X02 and dsPIC33FJ16GSX02/X04 family devices that you have received conform functionally to the current Device Data Sheet (DS70000318G), except for the anomalies described in this document.

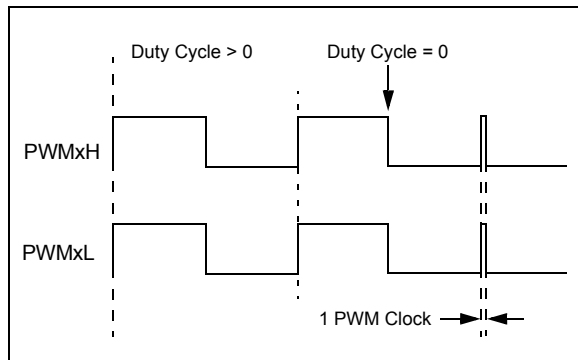
FIGURE 2: ISSUE EXAMPLE FOR REDUNDANT OUTPUT MODE

In Redundant Output mode (IOCONx<11:10> = 01) and Push-Pull Output mode (IOCONx<11:10> = 10), with the Immediate Update disabled (PWMCONx<0> = 0), when the Duty Cycle register is updated from a non-zero value to zero, a glitch pulse of a width equal to 1 PWM clock will appear at the next PWM period boundary, as shown in Figure 2 (for the Redundant Output mode). The Duty Cycle register refers to the PDCx register if PWMCONx<8> = 0 or the MDC register if PWMCONx<8> = 1.

Work around

If the application requires a zero duty cycle output, there are two possible work around methods:
