## Product Change Notification / SYST-21KRWH782

ERRATA - PIC32MX1XX/2XX/5XX 64/100-pin Family Silicon Errata and Data Sheet Clarification Revision

## PIC32MX1XX/2XX/5XX 64/100-pin Family Silicon Errata and Data Sheet Clarification

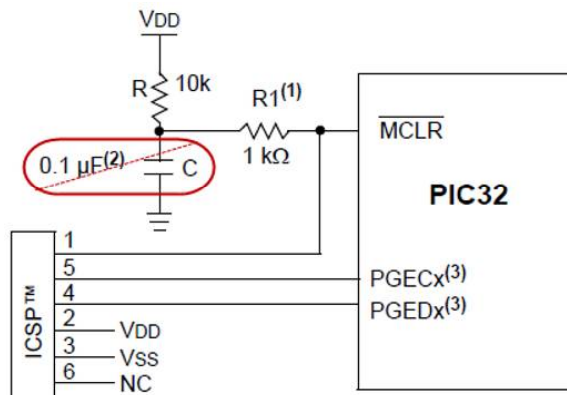
## 17. Module: I/O Port - Initial Pin State

On power-up depending on the VDD ramp rate, the I/O pins can be in an active random output driving state if  $\overline{\text{MCLR}}$  is active until a BOR event.

If, not using an external reset supervisor IC or equivalent, remove the  $\overline{\text{MCLR}}$  capacitor as shown below, and retain the  $\overline{\text{MCLR}}$  Pull-up resistor.

If using an external reset supervisor IC or equivalent, increase the value of the VCAP capacitor to  $\geq 47 \mu\text{F}$  ceramic or solid tantalum capacitor with an ESR  $\leq 1 \text{ ohm}$ .
