Product Change Notification / SYST-29FTIN870

ERRATA - dsPIC33EVXXXGM00X/10X Family Silicon Errata and Data Sheet Clarification Document Revision

dsPIC33EVXXXGM00X/10X Family Silicon Errata and Data Sheet Clarification

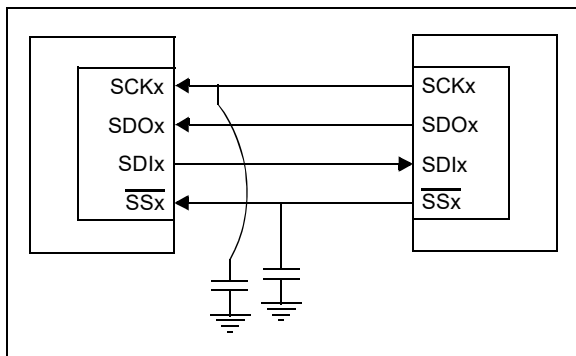
FIGURE 1:

When the SPIx module is configured in SPIx Slave mode (MSTEN bit (SPIxCON1[5]) = 0), the frame slave (FRMEN bit (SPIxCON2[15]) = 1) and the SPIFSD bit (SPIxCON2[14] = 1), in Standard Buffer mode with the Clock Polarity Select bit, CKP = 0, the data are not transmitted in both 8-bit and 16-bit mode, but the data are being received correctly.

Adding a capacitance on the signal, as shown in Figure 1, will help the data to be received properly.
