Product Change Notification / SYST-04AEAI643

ERRATA - dsPIC33EPXXXGS70X/80X Family Silicon Errata and Data Sheet Clarification

dsPIC33EPXXXGS70X/80X Family Silicon Errata and Data Sheet Clarification

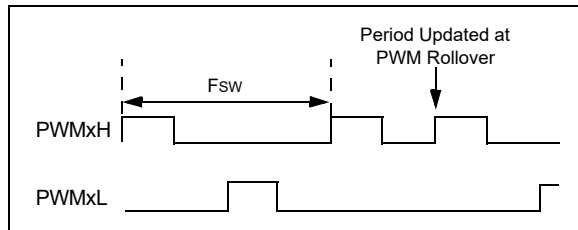
FIGURE 1:

When the PWM module is configured for Push-Pull mode ($IOCONx[11:10] = 0b10$) with the Enable Immediate Period Update bit enabled ($PTCON[10] = 1$), a write to the Period register that coincides with the period rollover event may cause the push-pull output logic to produce back-to-back pulses on the PWMx pins (see Figure 1).

Ensure that the update to the PWM Period register occurs away from the PWM rollover event by setting the EIPU bit ($PTCON[10] = 1$). Use either the PWM Special Event Trigger (SEVTCMP) or the PWM Primary Trigger (TRIGx) to generate a PWM Interrupt Service Routine (ISR) near the start of the PWM cycle. This ISR will ensure that period writes do not occur near the PWM period rollover event.

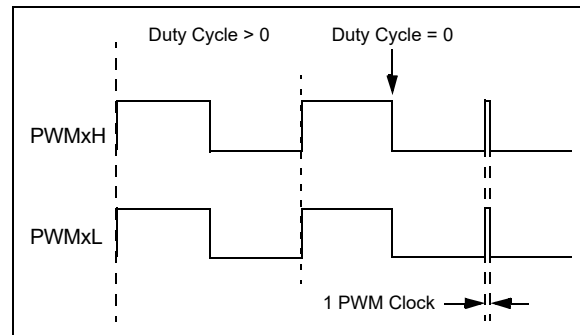
FIGURE 2: EXAMPLE FOR REDUNDANT OUTPUT MODE

In the Redundant Output mode ($IOCONx[11:10] = 0b01$) and Push-Pull Output mode ($IOCONx[11:10] = 0b10$), with the Immediate Update Enable bit disabled ($PWMCONx[0] = 0$), when the Duty Cycle register is updated from a non-zero value to zero, a glitch pulse of a width equal to 1 PWM clock will appear at the next PWM period boundary, as shown in Figure 2 (for the Redundant Output mode). The Duty Cycle register refers to the PDCx register if $PWMCONx[8] = 0$ or the MDC register if $PWMCONx[8] = 1$.

If the application requires a zero duty cycle output, there are two possible work around methods:

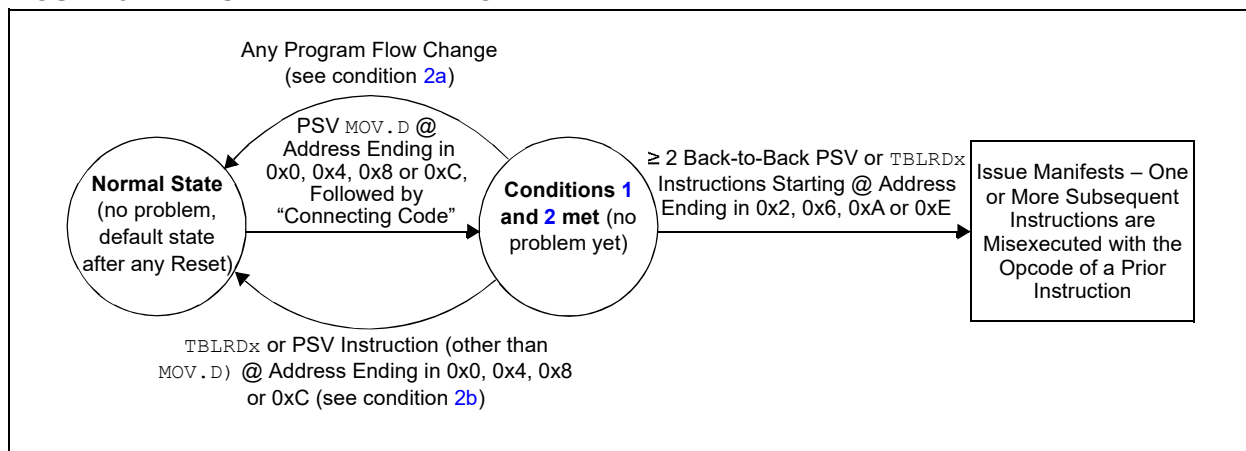
FIGURE 3: SIMPLIFIED BEHAVIOR

When two or more data Flash read instructions (via Program Space Visibility (PSV) read or Table Read) are executed back-to-back, one or more subsequent instructions can be misexecuted when all of the conditions in [Table 4](#) occur.

[Figure 3](#) provides an example of the effective behavior.

The issue can be avoided by ensuring any one or more of the requirements are not met. For example:

1. All instances of PSV `MOV.D` can be replaced with two PSV `MOV` instructions instead. Non-PSV `MOV.D` instructions acting on RAM/SFRs do not need to be modified; or
2. If not already present, a program flow change instruction (such as `BRA $+2`) can be inserted above back-to-back data Flash read sequences; or
3. Back-to-back data Flash read instruction sequences can be broken up by inserting a non-Flash read instruction (such as a `NOP`), in between the Flash read instructions; or
4. The alignment of the code can be shifted to avoid the required opcode location addresses.

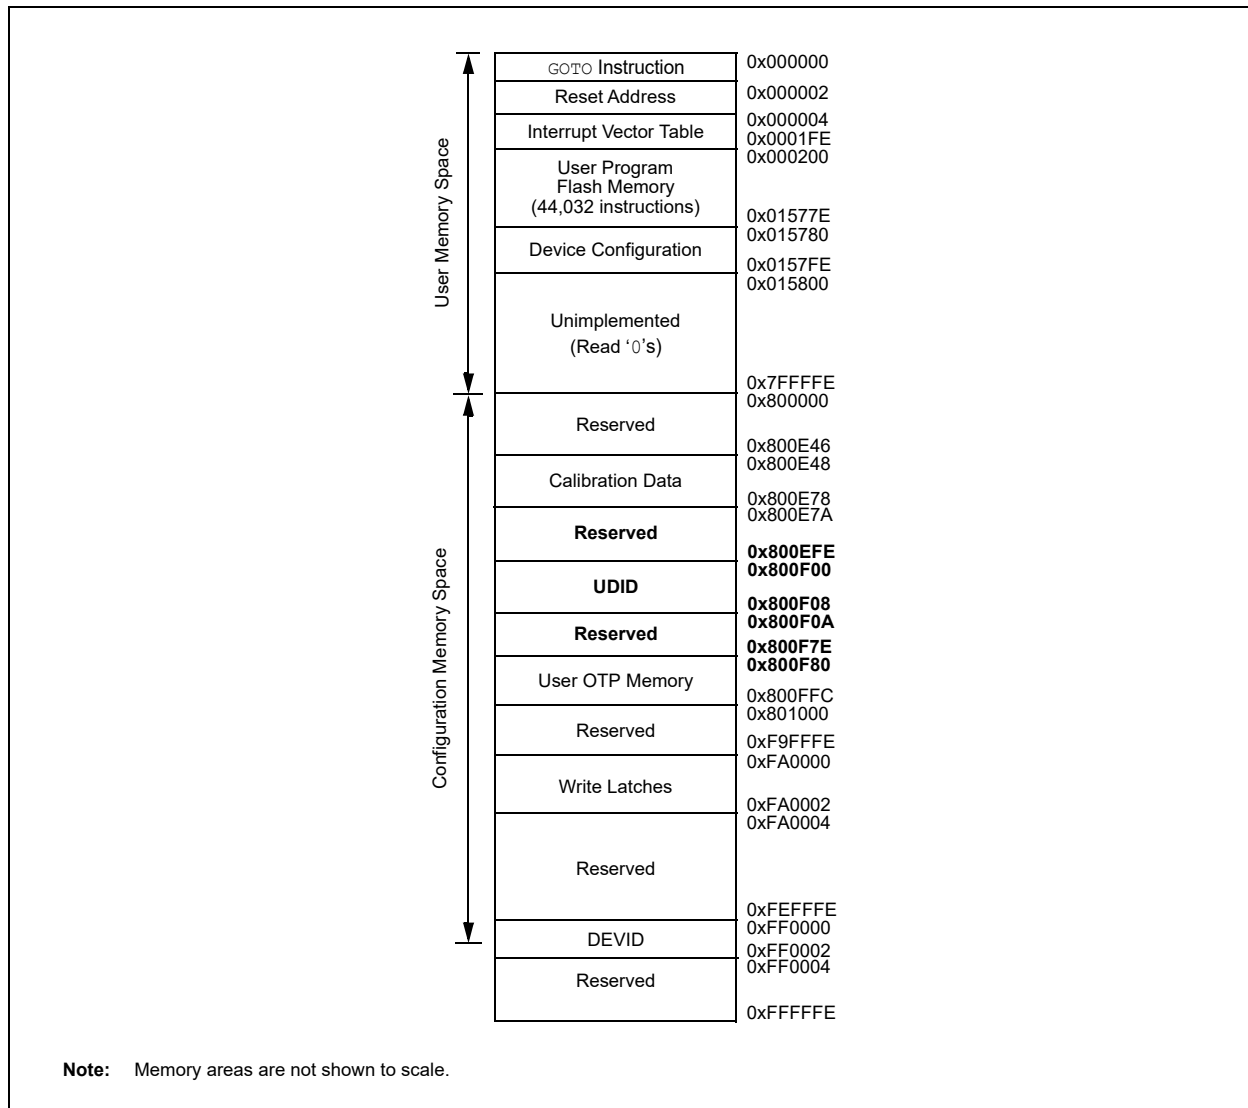
FIGURE 4-2: PROGRAM MEMORY MAP FOR dsPIC33EP128GS70X/80X DEVICES

In Figure 4-2, the following changes have been made as shown in **bold**:
