Product Change Notification / SYST-03MFRX853

ERRATA - dsPIC33EVXXXGM00X/10X Family Silicon Errata and Data Sheet Clarification

dsPIC33EVXXXGM00X/10X Family Silicon Errata and Data Sheet Clarification

The dsPIC33EVXXXGM00X/10X family devices that you have received conform functionally to the current Device Data Sheet (DS70005144H), except for the anomalies described in this document.

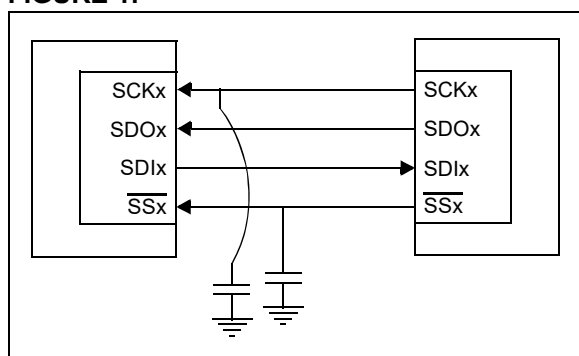
FIGURE 1:

When the SPIx module is configured in SPIx Slave mode (MSTEN bit (SPIxCON1[5]) = 0), the frame slave (FRMEN bit (SPIxCON2[15]) = 1) and the SPIFSD bit (SPIxCON2[14] = 1), in Standard Buffer mode with the Clock Polarity Select bit, CKP = 0, the data are not transmitted in both 8-bit and 16-bit mode, but the data are being received correctly.

Adding a capacitance on the signal, as shown in Figure 1, will help the data to be received properly.

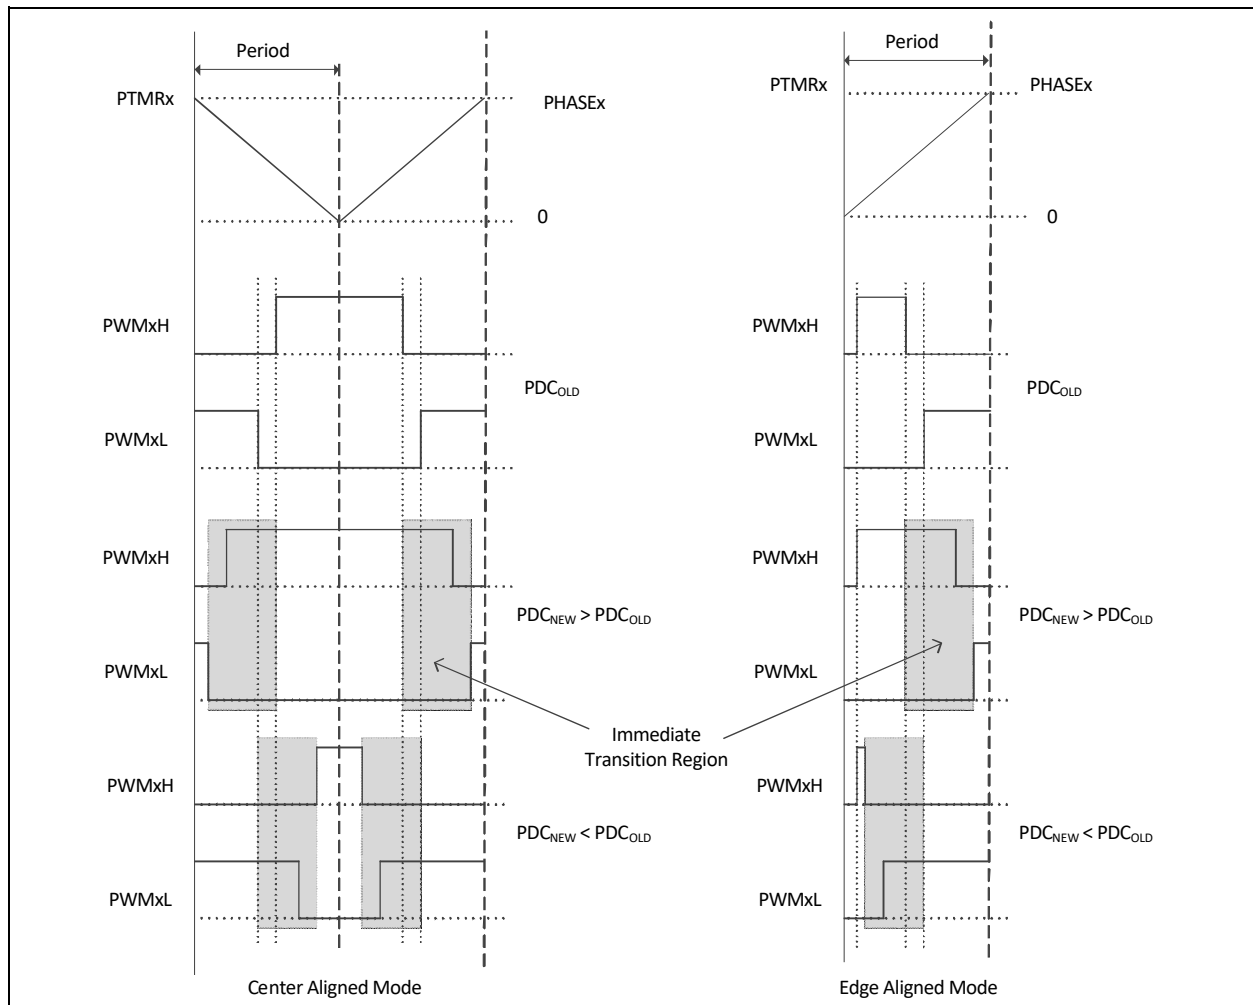
FIGURE 2: TIMING DIAGRAMS FOR CENTER-ALIGNED AND EDGE-ALIGNED MODES

The PWM generator may not assert dead time on the edges of transitions. This has been observed when all of the following conditions are present:

In [Figure 2](#), if the duty cycle write occurred in the shaded box, then PWMxH and PWMxL will make an immediate transition without dead time.

However, in most applications, the duty cycle update timing can be controlled using the TRIGx trigger or Special Event Trigger, such that the above mentioned conditions are avoided altogether.
