## Product Change Notification / SYST-11TJOJ589

ERRATA - PIC32MX1XX/2XX/5XX 64/100-pin Family Silicon Errata and Data Sheet Clarification

## PIC32MX1XX/2XX/5XX 64/100-pin Family Silicon Errata and Data Sheet Clarification

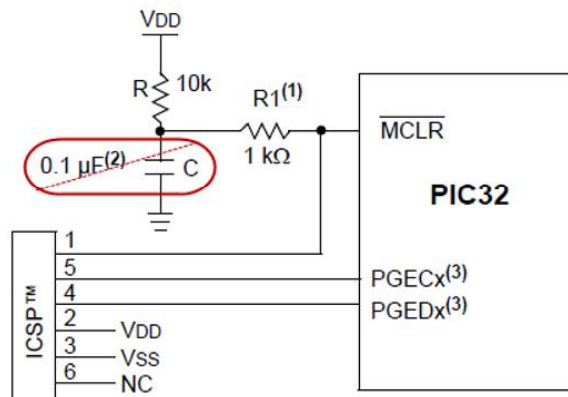
## 17. Module: I/O Port - Initial Pin State

On power-up depending on the VDD ramp rate, the I/O pins can be in an active random output driving state if  $\overline{\text{MCLR}}$  is active until a BOR event.

If, not using an external reset supervisor IC or equivalent, remove the  $\overline{\text{MCLR}}$  capacitor as shown below, and retain the  $\overline{\text{MCLR}}$  Pull-up resistor.

If using an external reset supervisor IC or equivalent, increase the value of the VCAP capacitor to  $\geq 47 \mu\text{f}$  ceramic or solid tantalum capacitor with an ESR  $\leq 1 \text{ ohm}$ .
