Product Change Notification / SYST-08HQLN222

ERRATA - PIC32MZ Embedded Connectivity with Floating Point Unit (EF) Family Silicon Errata and Data Sheet Clarification

PIC32MZ Embedded Connectivity with Floating Point Unit (EF) Family Silicon Errata and Data Sheet Clarification

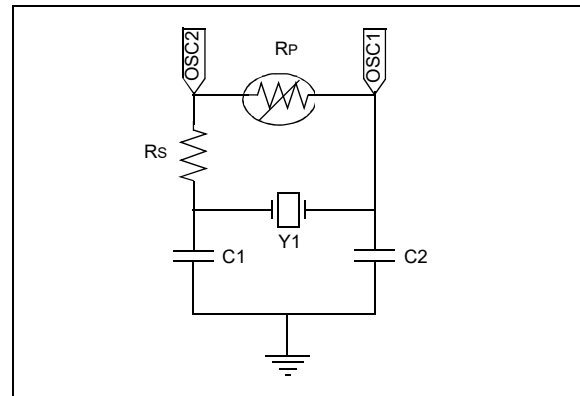
FIGURE 1: Posc CRYSTAL CIRCUIT

Revision A3 and B2 Silicon: The Posc has been tested in a normal power-up sequence and supports specific crystal operation.

The Primary Oscillator (Posc) has been characterized to operate at 8 MHz, 12 MHz, and 24 MHz when the circuit in [Figure 1](#) is implemented, and the operating conditions listed in [Table 3](#) are met.

TABLE 3: CRYSTAL SPECIFICATIONS

Crystal Frequency (see Note 1)	Series Resistor (Rs)	Posc Gain Setting POSCGAIN<1:0> (DEVCFG0<20:19>)	Posc Boost Setting POSCBOOST (DEVCFG0<21>)
8 MHz	2 kΩ	'0b00 (GAIN_0)	'0b1 (ON)
12 MHz	1 kΩ	'0b00 (GAIN_0)	'0b1 (ON)
24 MHz	0 kΩ	'0b00 (GAIN_0)	'0b1 (ON)

- Note 1:** Using any other crystal frequency will require special component selection and characterization.
Note 2: A parallel resistor (Rp) should not be used to increase the gain of the POSC.
