## Product Change Notification / SYST-21MVID450

ERRATA - dsPIC33EVXXXGM00X/10X Family Silicon Errata and Data Sheet Clarification Document Revision

## dsPIC33EVXXXGM00X/10X Family Silicon Errata and Data Sheet Clarification

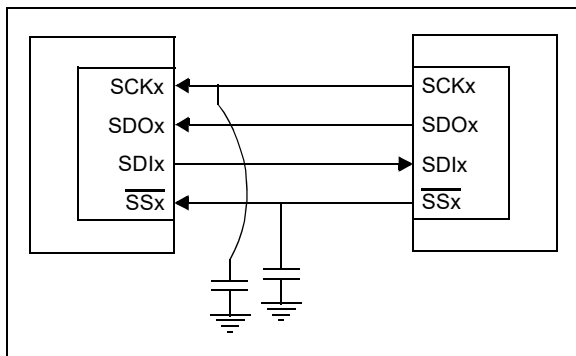
FIGURE 1:

When the SPIx module is configured in SPIx Slave mode (MSTEN bit (SPIxCON1[5]) = 0), the frame slave (FRMEN bit (SPIxCON2[15]) = 1) and the SPIFSD bit (SPIxCON2[14] = 1), in Standard Buffer mode with the Clock Polarity Select bit, CKP = 0, the data are not transmitted in both 8-bit and 16-bit mode, but the data are being received correctly.

Adding a capacitance on the signal, as shown in Figure 1, will help the data to be received properly.

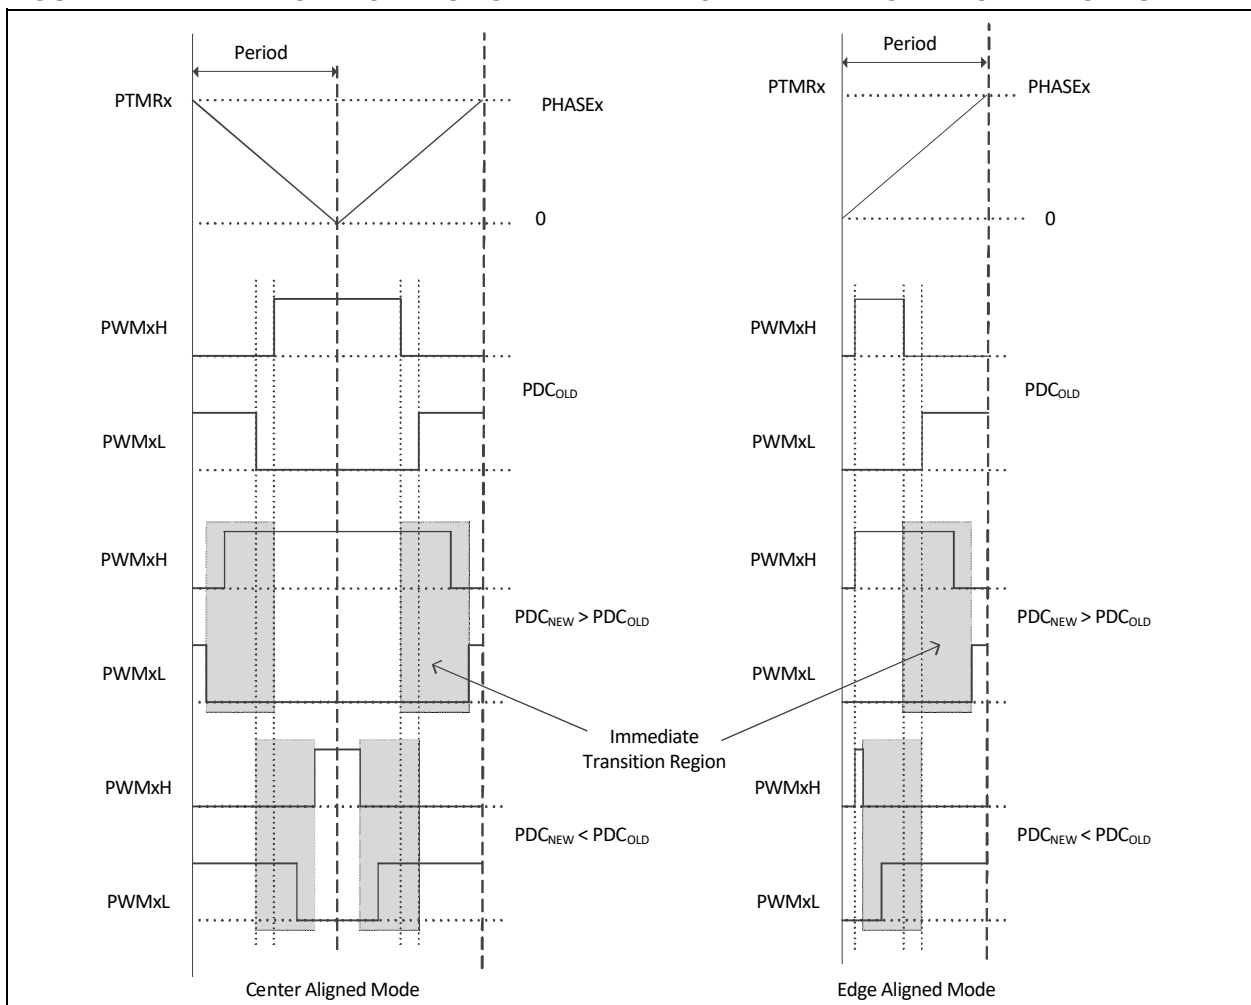
**FIGURE 2: TIMING DIAGRAMS FOR CENTER-ALIGNED AND EDGE-ALIGNED MODES**

The PWM generator may not assert dead time on the edges of transitions. This has been observed when all of the following conditions are present:

In [Figure 2](#), if the duty cycle write occurred in the shaded box, then PWMxH and PWMxL will make an immediate transition without dead time.

However, in most applications, the duty cycle update timing can be controlled using the TRIGx trigger or Special Event Trigger, such that the above mentioned conditions are avoided altogether.

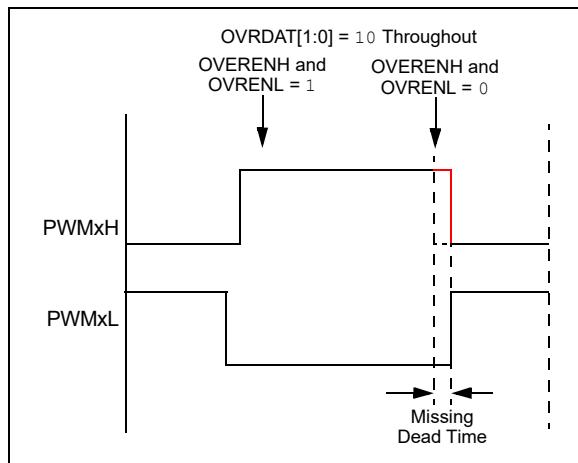
FIGURE 4:

- Output override synchronization is configured to occur on the CPU clock boundary (IOCONx[0] = 0);
- Both PWMxH and PWMxL overrides are enabled prior to the event (OVRENH and OVRENL are both '1'), and
- Both overrides are disabled (OVRENH and OVRENL are both '0') at the instant the dead time should be asserted (Figure 4). This has been observed in both Center-Aligned and Edge-Aligned modes.

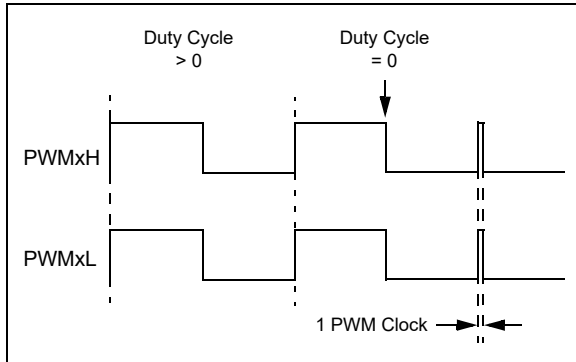
FIGURE 5:

In the Redundant Output mode (IOCONx[11:10] = 10) and Push-Pull Output mode (IOCONx[11:10] = 01) with Immediate Update disabled (PWMCONx[0] = 0), when the Duty Cycle register is updated from a non-zero value to zero, a glitch pulse of a width equal to one PWM clock will appear at the next PWM period boundary, as shown in Figure 5, for the Redundant Output mode. Here, the Duty Cycle register refers to the PDCx register if PWMCONx[8] = 0 or the MDC register if PWMCONx[8] = 1.

If the application requires a zero duty cycle output, there are two possible work around methods:

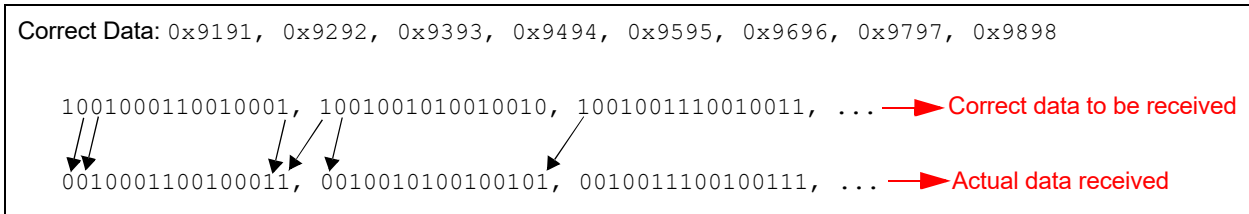
**FIGURE 6:**

Received data of the SPI are sampled one clock cycle late for the following conditions:

For example, the correct data that should be received are 0x9191, 0x9292, 0x9393, 0x9494, 0x9595, 0x9696, 0x9797, 0x9898, but the actual data received are 0x2323, 0x2525, 0x2727, 0x2929, 0x2B2B, 0x2D2D, 0x2F2F, 0x3130 (Figure 6).

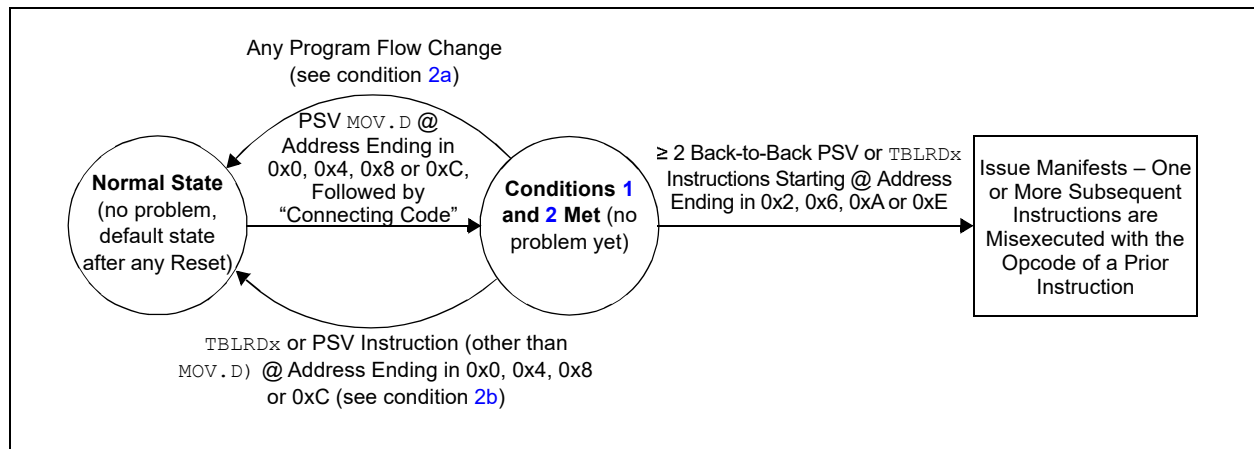
**FIGURE 7: SIMPLIFIED BEHAVIOR**

When two or more data Flash read instructions (via Program Space Visibility (PSV) read or table read) are executed back-to-back, one or more subsequent instructions can be misexecuted when all of the conditions in [Table 6](#) occur.

[Figure 7](#) provides an example of the effective behavior.

1. All instances of PSV MOV.D can be replaced with two PSV MOV instructions instead. Non-PSV MOV.D instructions acting on RAM/SFRs do not need to be modified; or
2. If not already present, a program flow change instruction (such as BRA \$+2) can be inserted above back-to-back data Flash read sequences; or
3. Back-to-back data Flash read instruction sequences can be broken up by inserting a non-Flash read instruction (such as a NOP), in between the Flash read instructions; or
4. The alignment of the code can be shifted to avoid the required opcode location addresses.

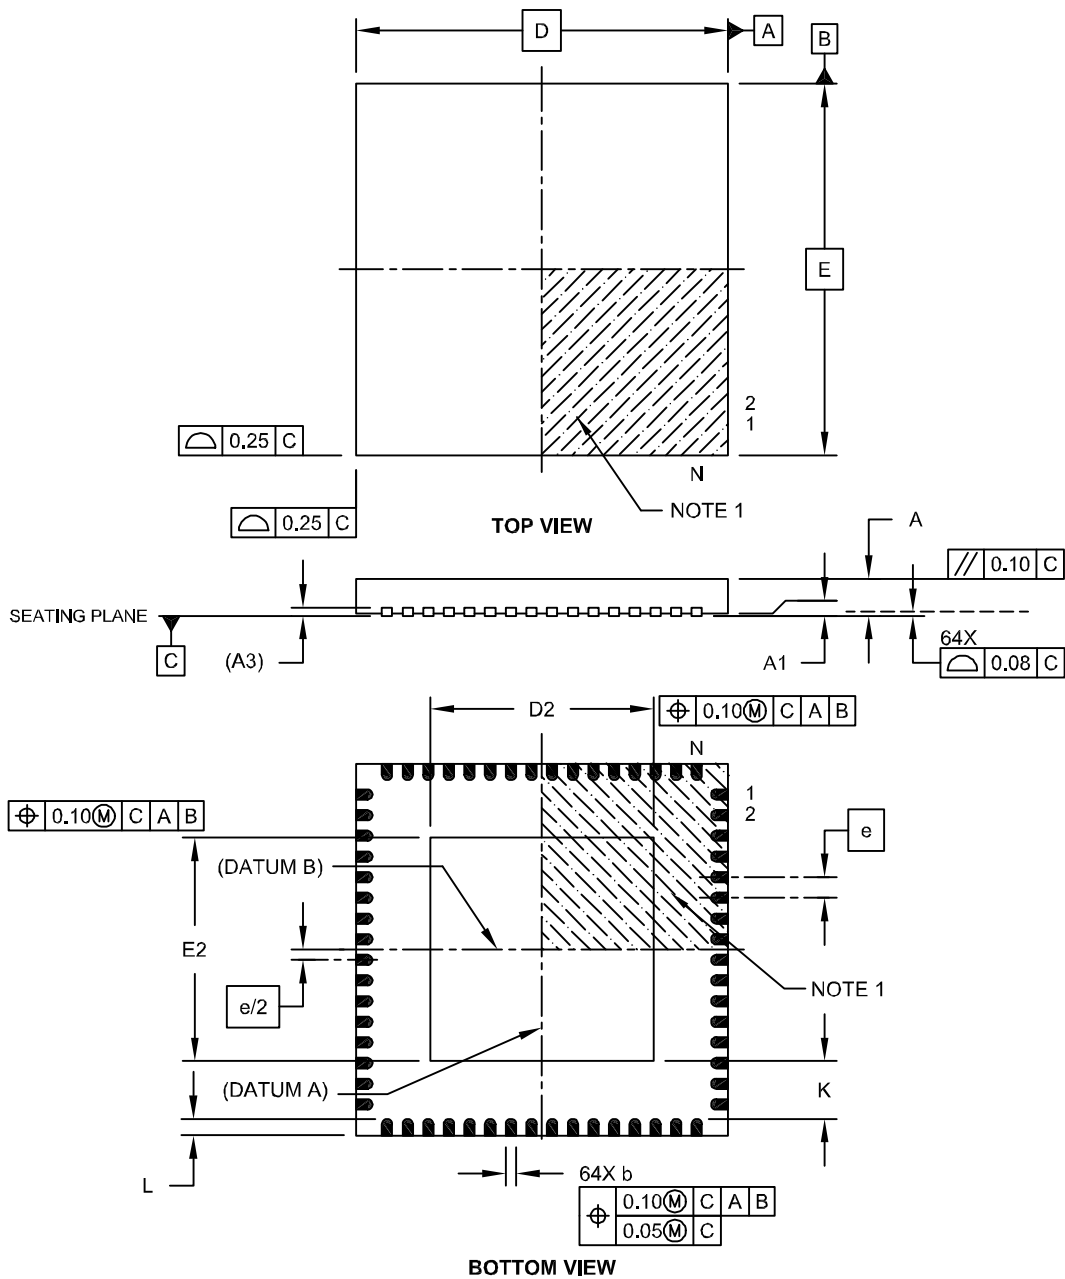
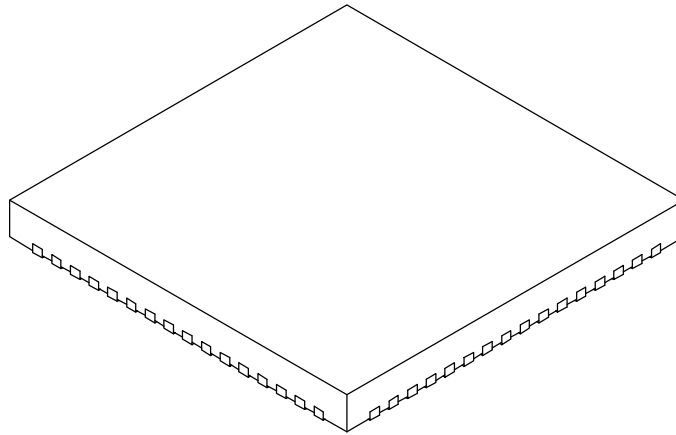
### 64-Lead Plastic Quad Flat, No Lead Package (MR) – 9x9x0.9 mm Body w/lt 5.40 x 5.40 Exposed Pad [QFN]

The package drawing for the 64-pin QFN device has been updated with the 64-Lead Plastic Quad Flat, No Lead package (MR) – 9x9x0.9 mm Body with 5.40x5.40 Exposed Pad [QFN] package drawing as shown below.
