Product Change Notification / SYST-210WVN419

ERRATA - PIC32MX1XX/2XX/5XX 64/100-pin Family Silicon Errata and Data Sheet Clarification

PIC32MX1XX/2XX/5XX 64/100-pin Family Silicon Errata and Data Sheet Clarification

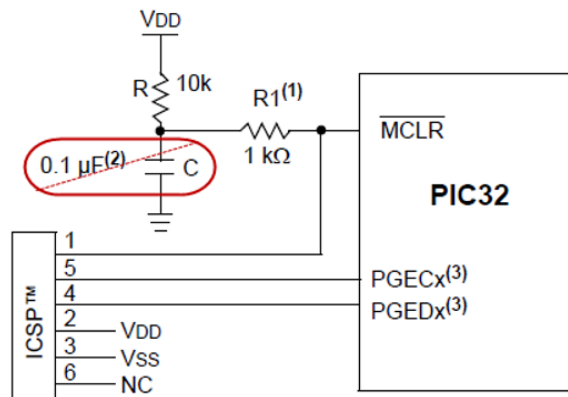
17. Module: I/O Port - Initial Pin State

On power-up depending on the VDD ramp rate, the I/O pins can be in an active random output driving state if $\overline{\text{MCLR}}$ is active until a BOR event.

Work around 1:

If, not using an external reset supervisor IC or equivalent, remove the $\overline{\text{MCLR}}$ capacitor as shown below, and retain the $\overline{\text{MCLR}}$ Pull-up resistor.
