Product Change Notification - SYST-16NCFL501

ERRATA - SAM G55 Series Family Silicon Errata and Data Sheet Clarifications

**SAM G55 Series Family
Silicon Errata and Data Sheet Clarification**

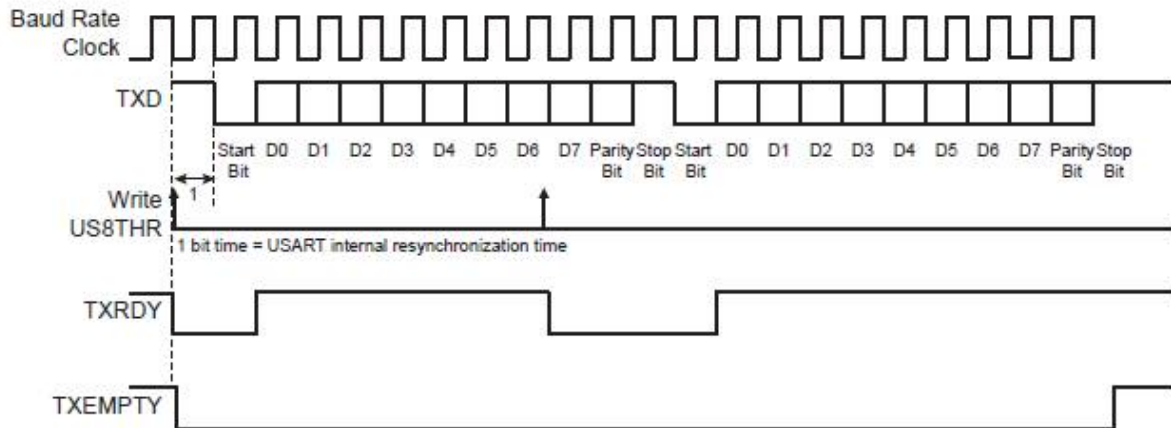
8. Module: USART - Transmitter Operations

Figure 30-6 is incorrect. The corrected figure is as shown below:
