Product Change Notification / SYST-27LQEU832

ERRATA - PIC32MZ Graphics (DA) Family Silicon Errata

PIC32MZ Graphics (DA) Family Silicon Errata and Data Sheet Clarification

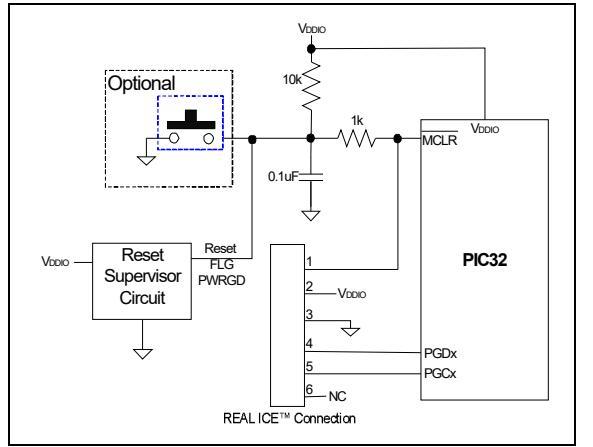
FIGURE 2: EXTERNAL RESET CIRCUIT

A system Reset is not generated on a BOR event (VPORIO < VDDIO < VBORIO). This will stop system clocks with all the I/O pin functions frozen in the present state until either VDDIO falls to VPORIO or VDDIO > VBORIO.

Reset device using a $\overline{\text{MCLR}}$ pin through an external reset supervisor/monitor is shown in Figure 2. Set the SMCLR (DEVCFG2<15>) configuration bit to '0', which makes the $\overline{\text{MCLR}}$ to act as a POR Reset instead of a normal system reset.

- Minimum Reset trip voltage of the external supervisor should be VBORIO (Max)+0.5V.
- The external reset supervisor/LDO output going to MCLR should have an open drain output to not interfere with the MPLAB programming/debug tools.

When this work around is implemented, the minimum VDDIO operating voltage of the application needs to be above the reset supervisor maximum trip voltage + 0.2V, where 0.2V compensates for variation in the external reset supervisor voltage.
