Product Change Notification / SYST-07KOTG694

ERRATA - LAN8670/1/2 10BASE-T1S Ethernet PHY Transceiver Silicon Errata and Data Sheet Clarifications Revision

10BASE-T1S Ethernet PHY Transceiver Silicon Errata and Data Sheet Clarifications

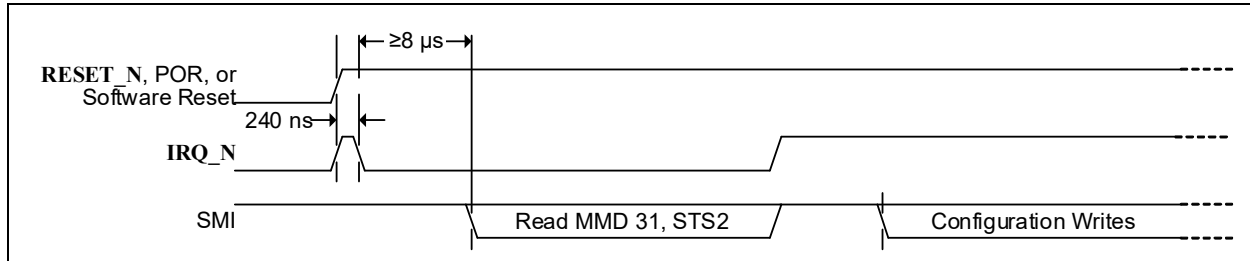
s4. Module: Incorrect reset indication on IRQ_N

The device does not properly assert the IRQ_N pin to interrupt the station management entity once it has been reset. The device should allow the IRQ_N pin to be pulled high when it is in reset and only assert IRQ_N low once it is ready for initialization by the station management entity. However, the device will assert IRQ_N low during reset. Once the device reset is deasserted, the IRQ_N pin will become deasserted for about 240 ns. The station management entity can only attempt communication with the device 8 μ s following reset.

When the device has been reset, the station management entity cannot immediately communicate with the device.

The station management entity will receive a false interrupt indication on IRQ_N when the device is reset. This may result in a failure to communicate with the device.

The station management entity must wait at least 8 μ s following reset to communicate with the device.
