Product Change Notification / SYST-29TDLI162

ERRATA - dsPIC33CK256MP508 Family Silicon Errata and Data Sheet Clarification Errata Document Revision

dsPIC33CK256MP508 Family Silicon Errata and Data Sheet Clarification

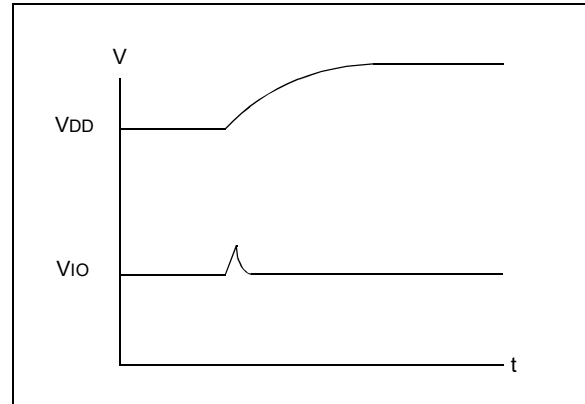
FIGURE 1-1: I/O RAMP

24. Module: I/O

During a fast device power-up when the V_{DD} ramp is less than 4 mS, the I/O pins may drive up to 100 μ A current for a duration of up to 10 μ S (Figure 1-1).

Example applications affected may include complementary power switches, where a transient current shoot-through might occur. High-voltage applications with complementary switches should power the high-voltage 200 μ Sec later than powering the dsPIC[®] device to avoid the current shoot-through. This behavior is specific to each device and not affected by aging.

1. Slow down the V_{DD} ramp time (greater than 4 mS for V_{DD} to ramp 0V to 3.3V).
2. Ensure the circuitry that is connected to the pins can endure this pulse.
