Product Change Notification / SYST-23CMIU808

ERRATA - dsPIC33CK256MP508 Family Silicon Errata and Data Sheet Clarification

dsPIC33CK256MP508 Family Silicon Errata and Data Sheet Clarification

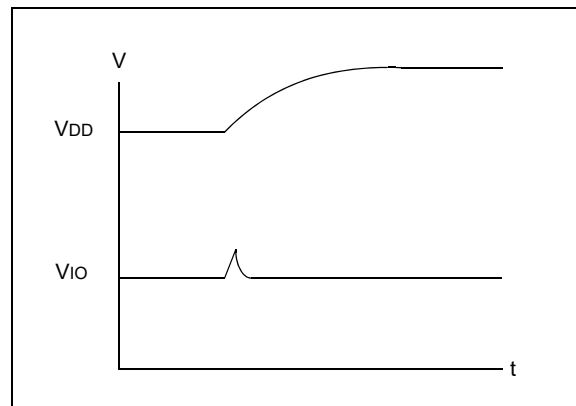
FIGURE 1-1: I/O RAMP

24. Module: I/O

During a fast device power-up when the V_{DD} ramp is less than 4 mS, the I/O pins may drive up to 100 μ A current for a duration of up to 10 μ S (Figure 1-1).

Example applications affected may include complementary power switches, where a transient current shoot-through might occur. High-voltage applications with complementary switches should power the high-voltage 200 μ Sec later than powering the dsPIC[®] device to avoid the current shoot-through. This behavior is specific to each device and not affected by aging.

1. Slow down the V_{DD} ramp time (greater than 4 mS for V_{DD} to ramp 0V to 3.3V).
2. Ensure the circuitry that is connected to the pins can endure this pulse.
