PIC18F26/45/46K40 Family
Silicon Errata and Data Sheet Clarification

The PIC18F26/45/46K40 family devices that you have received conform functionally to the current Device Data Sheet (DS40001816**E**), except for the anomalies described in this document.

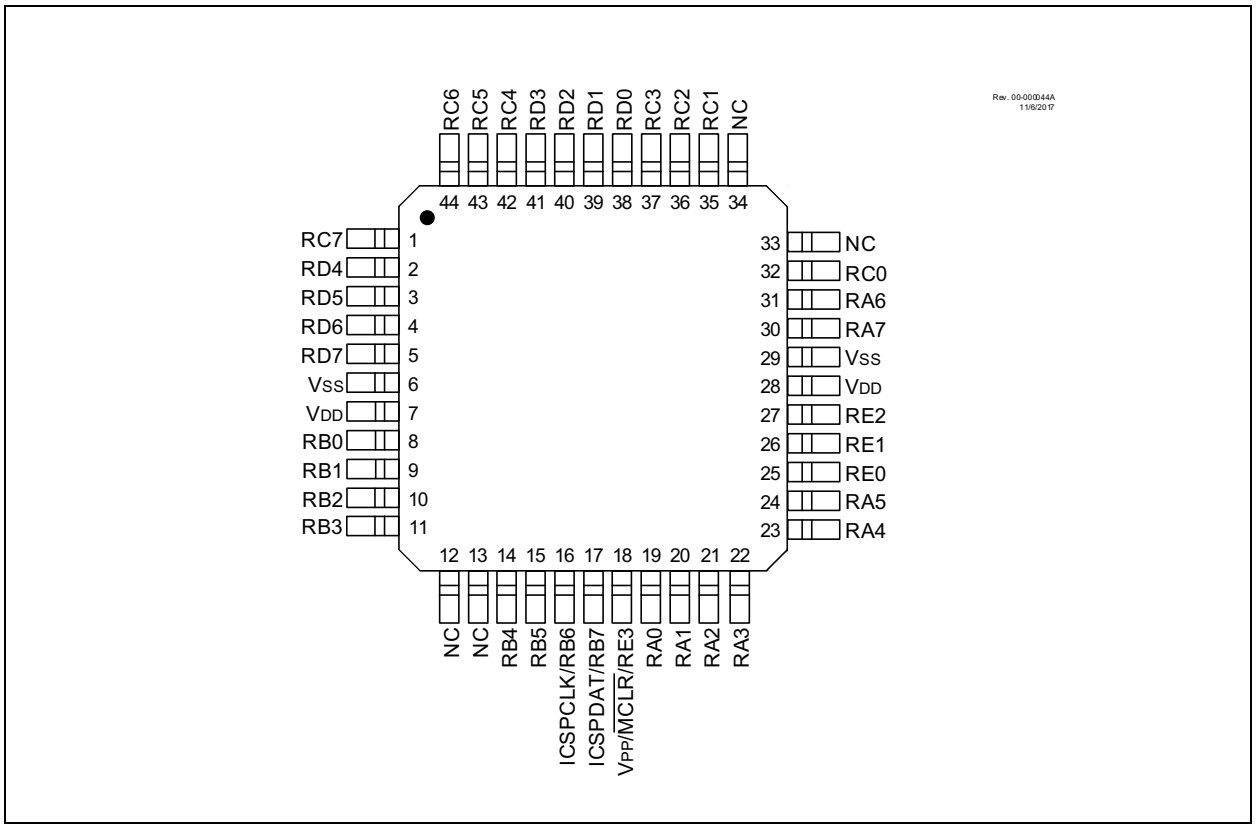
1.1 44-pin TQFP package

For the 44-pin TQFP, use the following pin diagram:

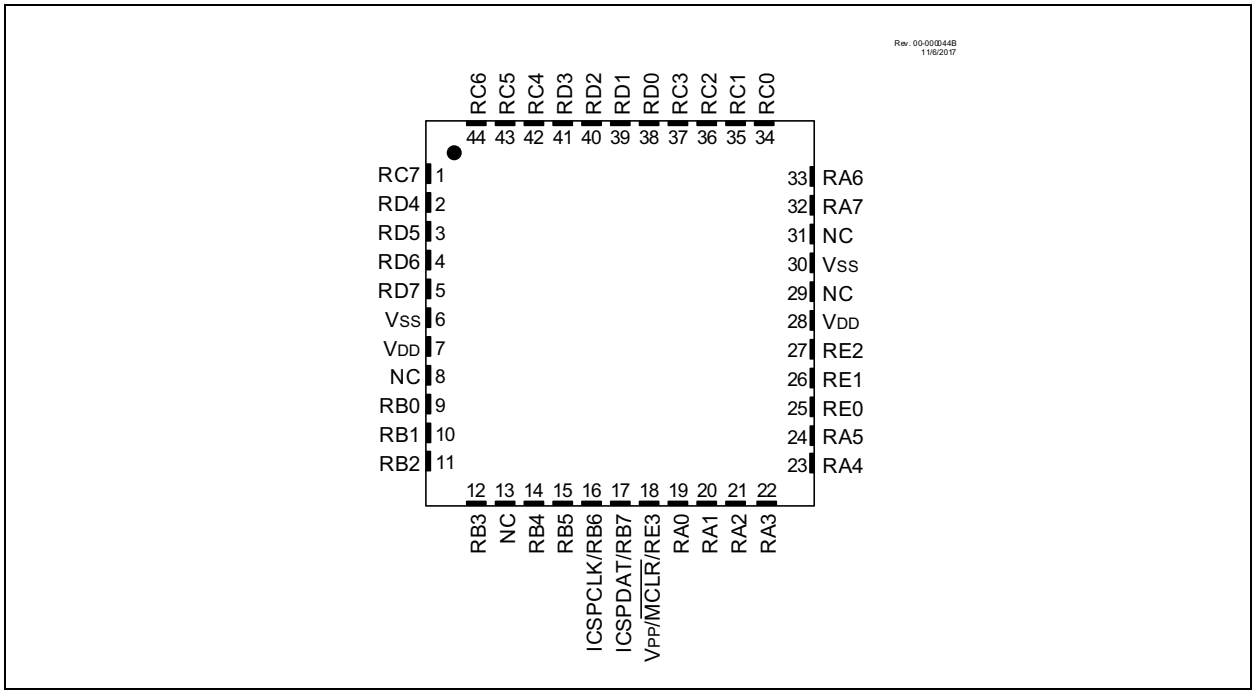
1.2 44-pin QFN package

For the 44-pin QFN, use the following pin diagram:

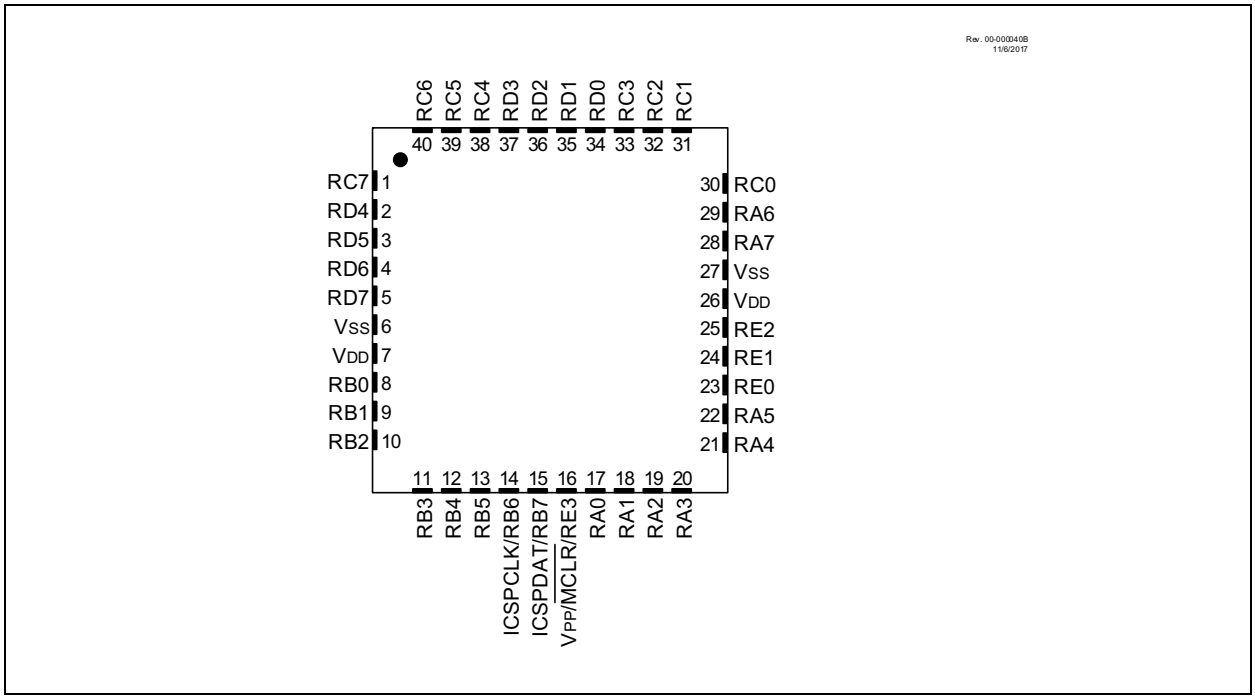
1.3 40-pin UQFN package

For the 40-pin UQFN, use the following pin diagram:
