Product Change Notification - SYST-24EBIU654

ERRATA - dsPIC33CK256MP508 Family Silicon Errata and Data Sheet Clarification

dsPIC33CK256MP508 Family Silicon Errata and Data Sheet Clarification

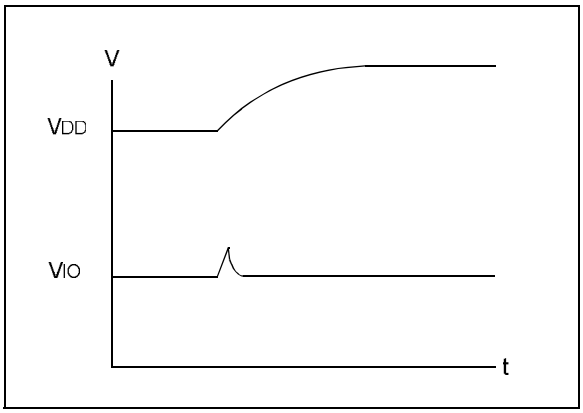
FIGURE 1-1: I/O RAMP

During a fast device power-up when the VDD ramp is less than 4 mS, the I/O pins may drive up to 100 µA current for a duration of up to 10 µS (Figure 1-1).

Example applications affected may include complementary power switches, where a transient current shoot-through might occur. High-voltage applications with complementary switches should power the high-voltage 200 µSec later than powering the dsPIC® device to avoid the current shoot-through. This behavior is specific to each device and not affected by aging.

1. Slow down the VDD ramp time (greater than 4 mS for VDD to ramp 0V to 3.3V).
2. Ensure the circuitry that is connected to the pins can endure this pulse.
