Product Change Notification - SYST-09HZSA980

ERRATA - PIC32MZ Embedded Connectivity with Floating Point Unit (EF) Family Silicon Errat

PIC32MZ Embedded Connectivity with Floating Point Unit (EF) Family Silicon Errata and Data Sheet Clarification

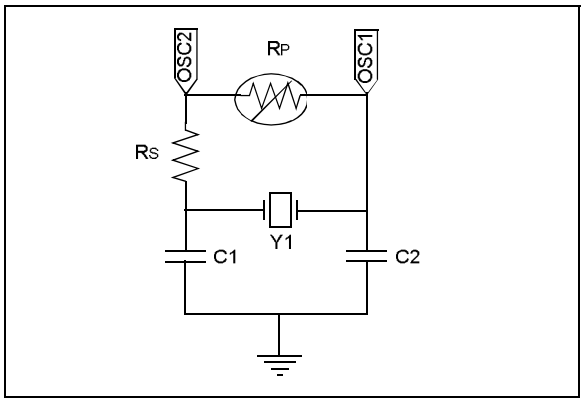
FIGURE 1: POSC CRYSTAL CIRCUIT

Revision A1 Silicon: A crystal oscillator cannot be used as an input to the Primary Oscillator (POSC) pins OSC1 and OSC2.

Revision A3 and B2 Silicon: The POSC has been tested in a normal power-up sequence and supports specific crystal operation.

The Primary Oscillator (POSC) has been characterized to operate at 8 MHz, 12 MHz, and 24 MHz when the circuit in Figure 1 is implemented, and the operating conditions listed in Table 3 are met.

Crystal Frequency (see Note 1)	Series Resistor (Rs)	POSC Gain Setting POSCGAIN<1:0> (DEVCFG0<20:19>)	POSC Boost Setting POSCBOOST (DEVCFG0<21>)
8 MHz	2 kΩ	'0b00 (GAIN_0)	'0b1 (ON)
12 MHz	1 kΩ	'0b00 (GAIN_0)	'0b1 (ON)
24 MHz	0 kΩ	'0b00 (GAIN_0))	'0b1 (ON)

Note 1: Using any other crystal frequency will require special component selection and characterization.

2: A parallel resistor (RP) should not be used to increase the gain of the POSC.

Alternatively, use an external clock or the Internal FRC oscillator.
