Product Change Notification - SYST-21LMFR637

ERRATA - PIC32MX1XX/2XX/5XX 64/100-pin Family Silicon Errata and Data Sheet Clarification

PIC32MX1XX/2XX/5XX 64/100-pin Family Silicon Errata and Data Sheet Clarification

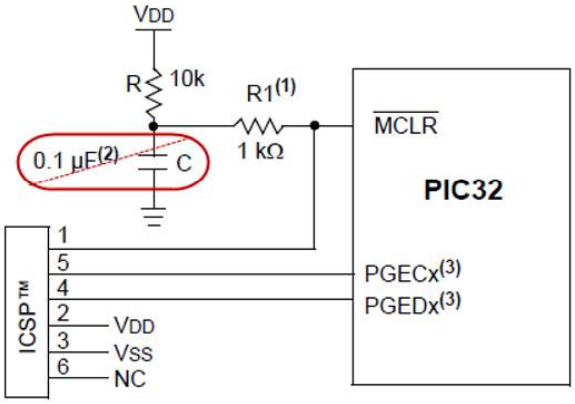
17. Module: I/O Port - Initial Pin State

On power-up depending on the VDD ramp rate, the I/O pins can be in an active random output driving state if $\overline{MCLR}$ is active until a BOR event.

Work around 1:

If, not using an external reset supervisor IC or equivalent, remove the $\overline{MCLR}$ capacitor as shown below, and retain the $\overline{MCLR}$ Pull-up resistor.

Work around 2:

If using an external reset supervisor IC or equivalent, increase the value of the VCAP capacitor to ≥47 µf ceramic or solid tantalum capacitor with an ESR ≤ 1 ohm.
