Product Change Notification / SYST-21NWMU176

ERRATA - dsPIC33CH512MP508 Family Silicon Errata and Data Sheet Clarification

dsPIC33CH512MP508 Family Silicon Errata and Data Sheet Clarification

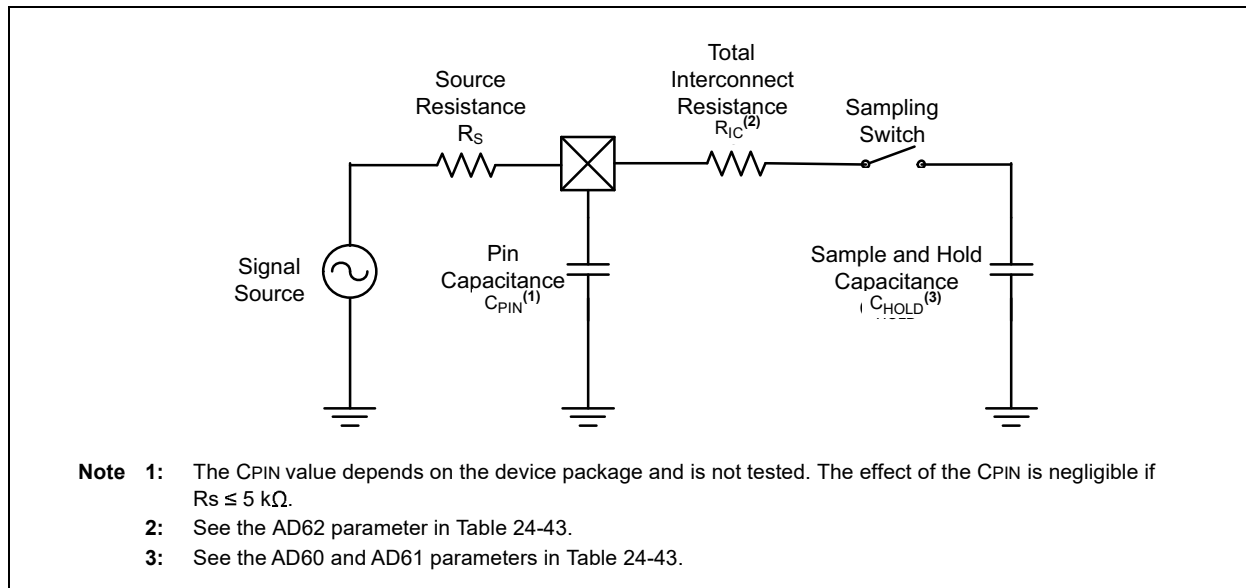
FIGURE: ADC ANALOG INPUT MODEL

The analog input model of the ADC is shown in the figure below.

The total acquisition time for the Analog-to-Digital conversion is a function of the Holding Capacitor (C_{HOLD}) charge time. For the ADC module to meet its specified accuracy, the Holding Capacitor (C_{HOLD}) must be allowed to fully charge to the voltage level on the analog input pin. The Signal Source Impedance (R_S) and the Interconnect Impedance (R_{IC}) combine to affect the time required to charge the C_{HOLD} . The total resistance ($R_S + R_{IC}$) must therefore, be small enough to fully charge the Holding Capacitor within the selected sample time.
