Information note

N° 10269AERRA

Errata sheet V1.9 affecting products TC39x_BC

Device TC39x
Marking/Step (E)ES-BC, BC
Package see Data Sheet

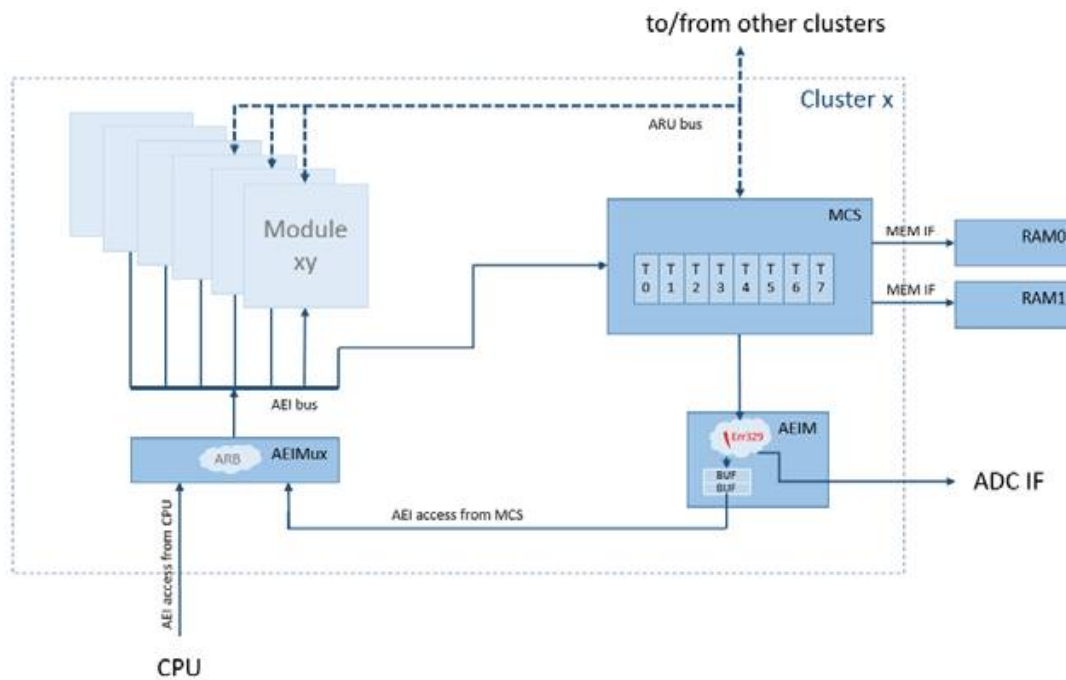
Figure 5 Cluster-internal AEI network

Problem GTM_AI.329 is related to a potential incorrect handling of MCS access requests to the AEI bus at the AEIM entry stage in case that one AEIM buffer is already filled. If in such a case a new access request from MCS enters the AEIM logic during a very specific time window (related to progress on the AEI bus), the AEIM logic might signalize incorrect parameters back to MCS that could result in incorrect data, the loss of data or a repetitive execution of MCS accesses to AEI.

In [Figure 7](#), a potential risk for the occurrence of problem GTM_AI.329 is illustrated. Here the first buffer of the AEIM (green) is still waiting for the access to the AEI bus while a second AEI bus access from MCS arrives at the AEIM (yellow access path). Under certain, but for the user unpredictable timing conditions, this second AEI bus access arriving at the AEIM can trigger the misbehavior described in problem GTM_AI.329.

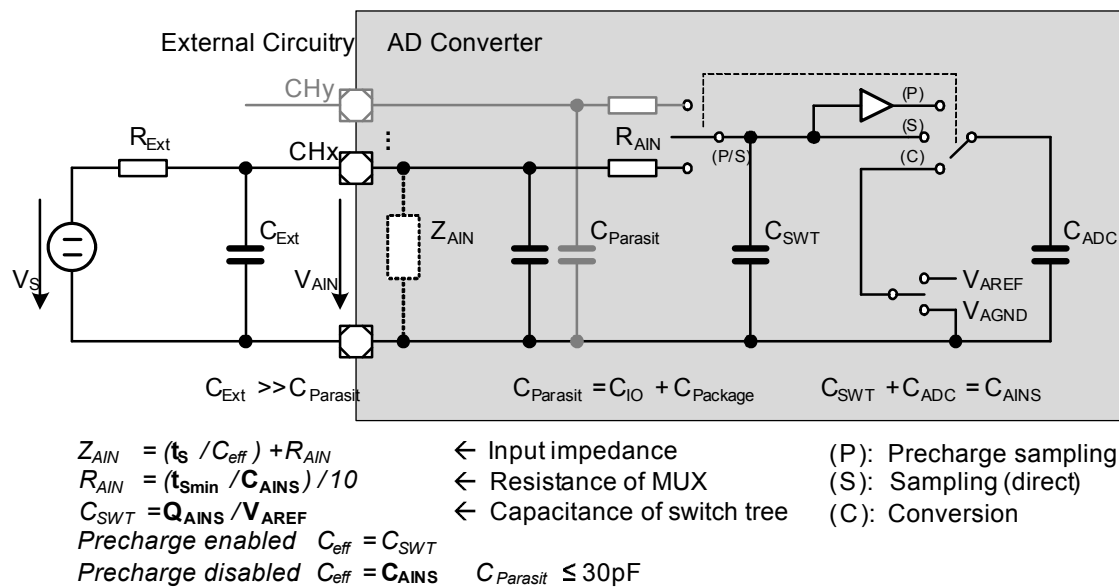
Figure 9 Equivalent Circuitry for Analog Inputs

Figure “Equivalent Circuitry for Analog Inputs” will be modified in future revisions of the Data Sheet, including the term $C_{\text{Parasit}} \leq 30 \text{ pF}$, as shown in the following figure:

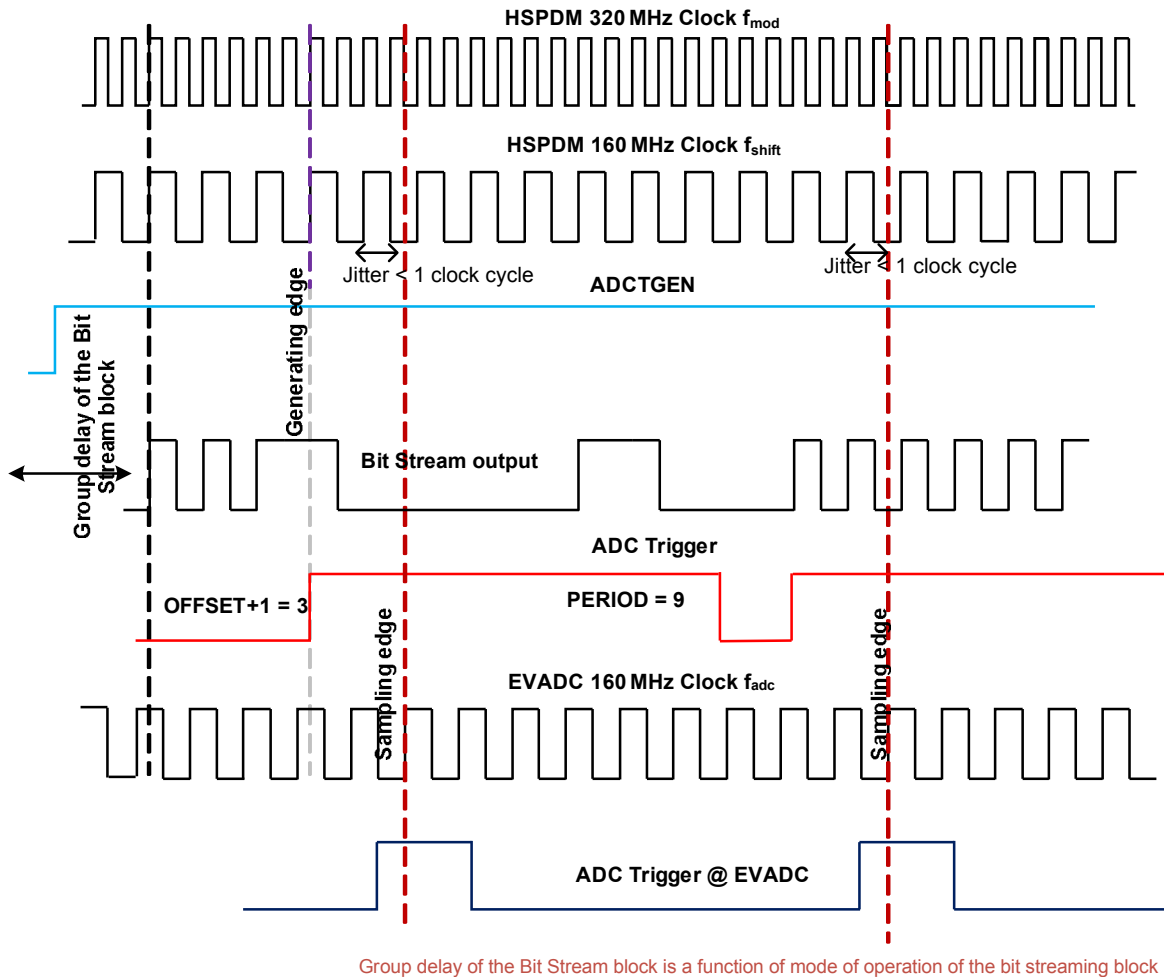
Figure 13 ADC Trigger Concept

HSPDM_TC.H004 ADC Trigger Concept - Figure update

Figure “ADC Trigger Concept” in the current version of the HSPDM chapter of the TC3xx User’s Manual shall be replaced with the following updated figure:
