Information note

N° 10292AERRA

Errata sheet V1.10 affecting products TC39x_BC

Subject Errata sheet V1.10 affecting products TC39x_BC

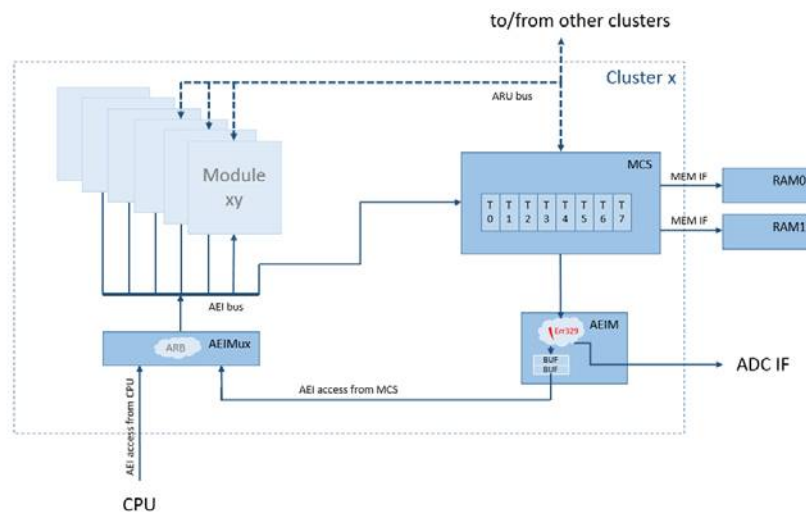
Figure 5 Cluster-internal AEI network

As an AEI bus access of a given MCS thread can be delayed either due to an ongoing AEI bus access from CPU or a multi cycle AEI access from another MCS thread, the AEIM contains buffers to store MCS bus accesses to AEI that cannot be served immediately.

As accesses to ADC from MCS point of view are not different from AEI bus accesses, these ADC accesses are forwarded to the AEIM in the same way and on the same interfaces as MCS accesses to the AEI bus. The AEIM will identify the ADC accesses by their targeted address space and forward them to the GTM external ADC. As ADC accesses will always be served with zero wait time, these ADC accesses are not routed through the AEIM buffers.

Problem GTM_AI.329 is related to a potential incorrect handling of MCS access requests to the AEI bus at the AEIM entry stage in case that one AEIM buffer is already filled. If in such a case a new access request from MCS enters the AEIM logic during a very specific time window (related to progress on the AEI bus), the AEIM logic might signalize incorrect parameters back to MCS that could result in incorrect data, the loss of data or a repetitive execution of MCS accesses to AEI.
