## **Information note**

**N° 10296AERRA**

**Errata sheet V1.8 affecting products TC37x\_AA**

**Subject** Errata sheet V1.8 affecting products TC37x\_AA

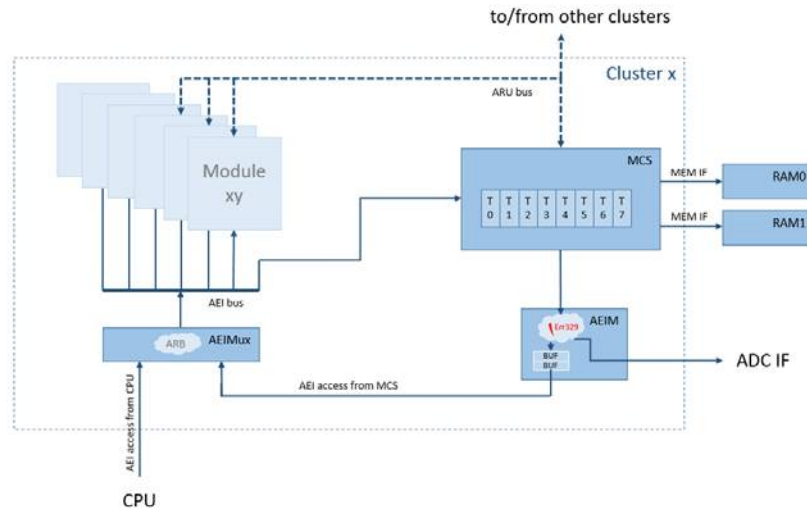
**Figure 5 Cluster-internal AEI network**

Problem GTM\_AI.329 is related to a potential incorrect handling of MCS access requests to the AEI bus at the AEIM entry stage in case that one AEIM buffer is already filled. If in such a case a new access request from MCS enters the AEIM logic during a very specific time window (related to progress on the AEI bus), the AEIM logic might signalize incorrect parameters back to MCS that could result in incorrect data, the loss of data or a repetitive execution of MCS accesses to AEI.

To avoid the potential occurrence of problem GTM\_AI.329 it has to be ensured that not more than 1 AEIM buffer gets filled due to backpressure in the AEI bus system.

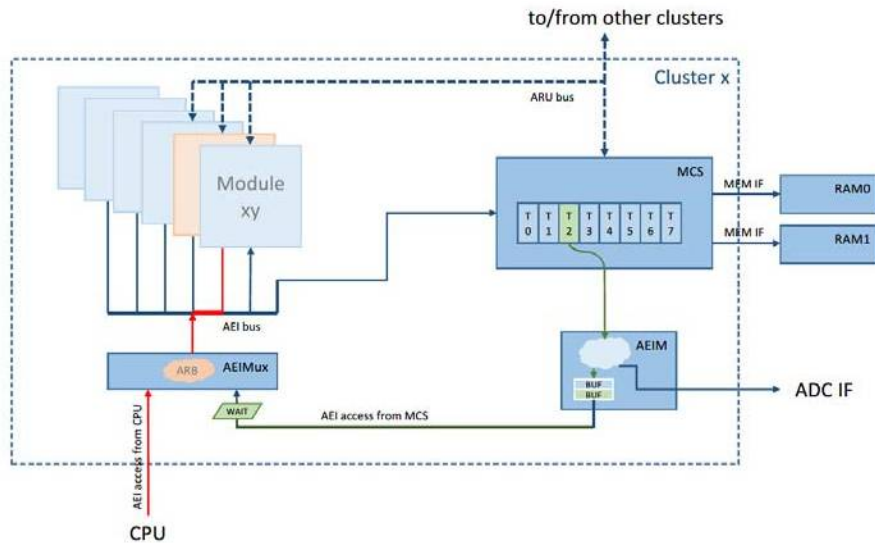
**Figure 6 MCS AEI master access path**

**Figure 6** shows an uncritical traffic situation. Here an access of a MCS thread to the AEI bus (green access path) is temporary delayed due to an ongoing AEI bus access from the CPU (red access path). The MCS access to the AEI bus will be safely buffered at the AEIM (green buffer). As soon as the CPU access to the AEI bus completes, the buffered AEI bus access from MCS will be executed.

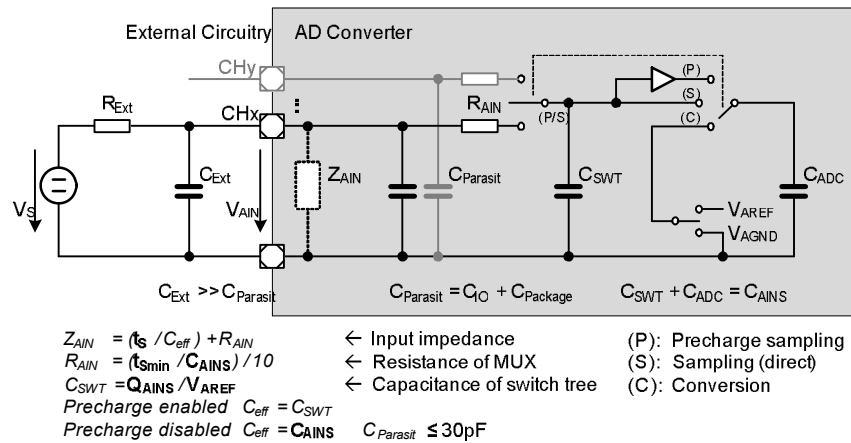
Figure 9 Equivalent Circuitry for Analog Inputs

Figure “Equivalent Circuitry for Analog Inputs” will be modified in future revisions of the Data Sheet, including the term  $C_{\text{Parasit}} \leq 30$  pF, as shown in the following figure:
