Information note

N° 10375AERRA

Errata sheet V1.11 affecting products TC37x_AA

Subject Errata sheet V1.11 affecting products TC37x_AA

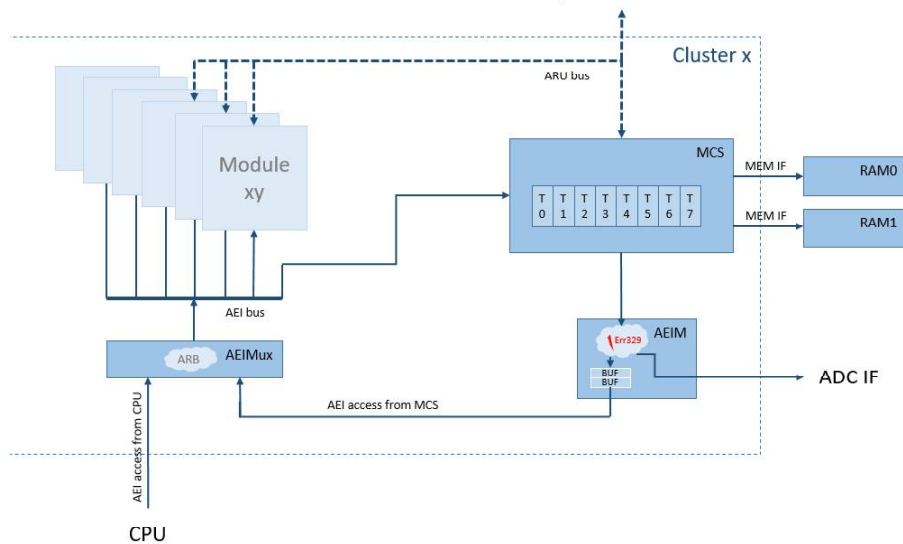
Figure 4 Cluster-internal AEI network

As an AEI bus access of a given MCS thread can be delayed either due to an ongoing AEI bus access from CPU or a multi cycle AEI access from another MCS thread, the AEIM contains buffers to store MCS bus accesses to AEI that cannot be served immediately.

As accesses to ADC from MCS point of view are not different from AEI bus accesses, these ADC accesses are forwarded to the AEIM in the same way and on the same interfaces as MCS accesses to the AEI bus. The AEIM will identify the ADC accesses by their targeted address space and forward them to the GTM external ADC. As ADC accesses will always be served with zero wait time, these ADC accesses are not routed through the AEIM buffers.

Problem GTM_AI.329 is related to a potential incorrect handling of MCS access requests to the AEI bus at the AEIM entry stage in case that one AEIM buffer is already filled. If in such a case a new access request from MCS enters the AEIM logic during a very specific time window (related to progress on the AEI bus), the AEIM logic might signalize incorrect parameters back to MCS that could result in incorrect data, the loss of data or a repetitive execution of MCS accesses to AEI.
