Information note

N° 10403AERRA

Errata sheet V2.00 affecting products TC37x_AA

Subject Errata sheet V2.0 affecting products TC37x_AA

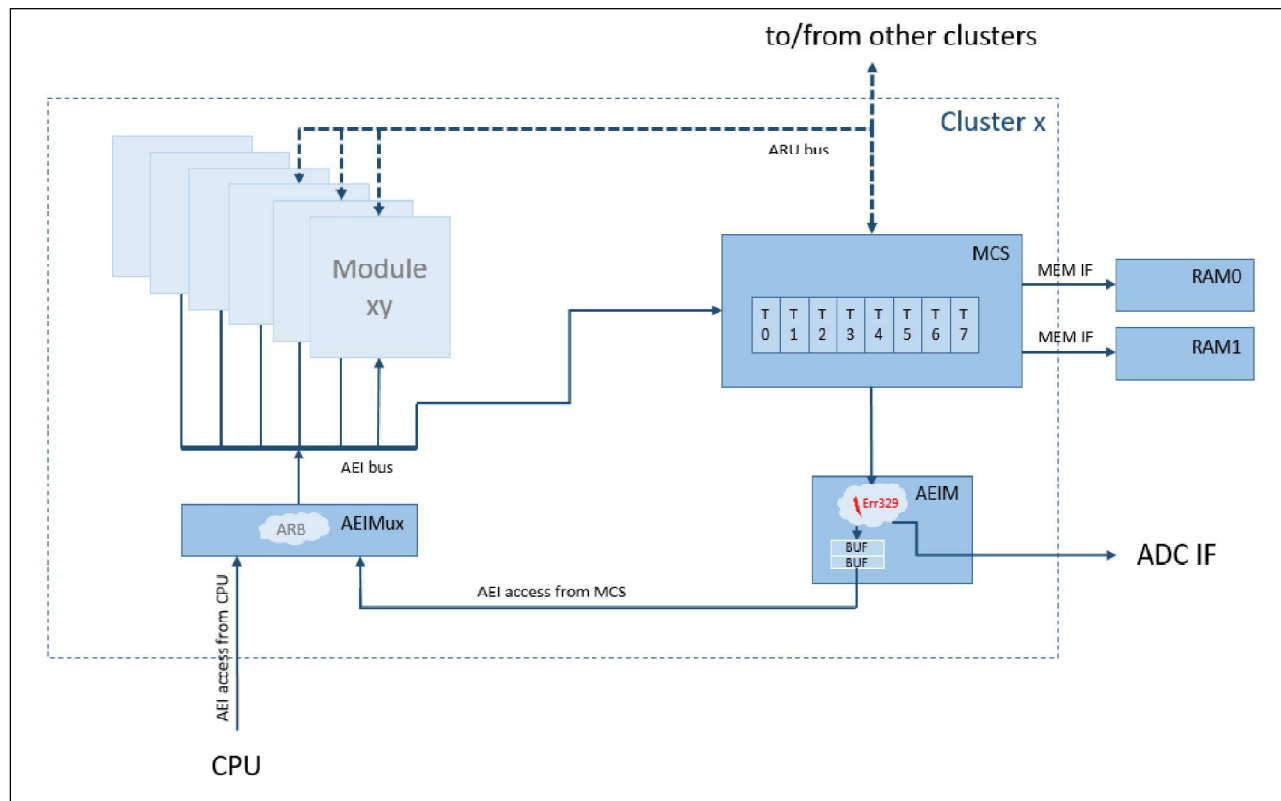
Figure 4 Cluster-internal AEI network

Problem GTM_AI.329 is related to a potential incorrect handling of MCS access requests to the AEI bus at the AEIM entry stage in case that one AEIM buffer is already filled. If in such a case a new access request from MCS enters the AEIM logic during a very specific time window (related to progress on the AEI bus), the AEIM logic might signalize incorrect parameters back to MCS that could result in incorrect data, the loss of data or a repetitive execution of MCS accesses to AEI.

MCS AEI master port usage scenarios proven to avoid the problematic traffic conditions under all circumstances include the usage scenarios described in the workaround section of this erratum. Usage of MCS to AEI or ADC communication not covered by tested scenarios must be avoided.
