## Product Change Notification / SYST-21MVID450

ERRATA - dsPIC33EVXXXGM00X/10X Family Silicon Errata and Data Sheet Clarification Document Revision

## dsPIC33EVXXXGM00X/10X Family Silicon Errata and Data Sheet Clarification

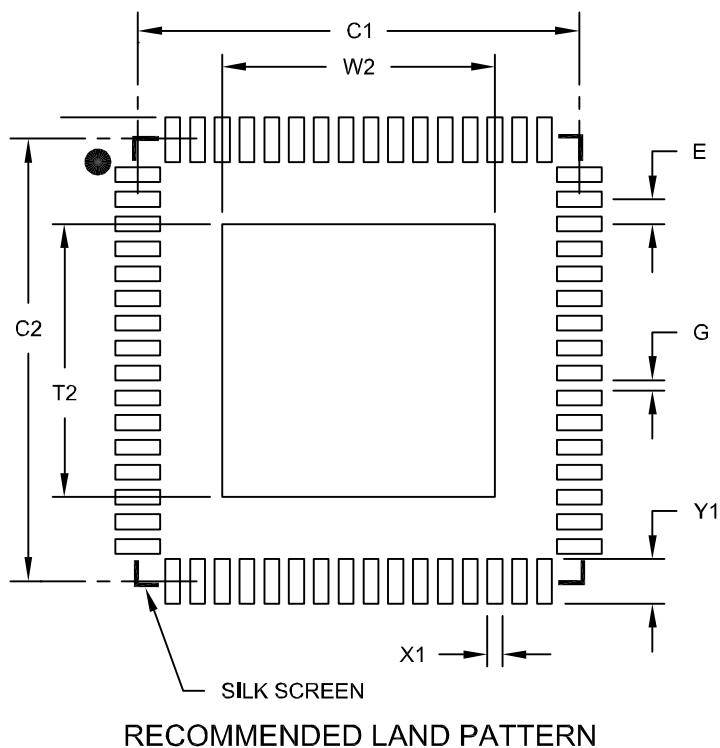
64-Lead Plastic Quad Flat, No Lead Package (MR) – 9x9x0.9 mm Body [QFN]  
With 0.40 mm Contact Length and 5.40x5.40mm Exposed Pad

Units		MILLIMETERS		
Dimension Limits		MIN	NOM	MAX
Contact Pitch	E	0.50 BSC		
Optional Center Pad Width	W2			5.50
Optional Center Pad Length	T2			5.50
Contact Pad Spacing	C1		8.90	
Contact Pad Spacing	C2		8.90	
Contact Pad Width (X64)	X1			0.30
Contact Pad Length (X64)	Y1			0.85
Distance Between Pads	G	0.20
