## Product Change Notification Software Release Notes

### mPower™ Edge Intelligence Software mPower 5.3.3

### MultiTech Conduit® AP Access Point MultiTech Conduit® Programmable Gateway MultiTech Conduit® IP67 Base Station MultiTech Conduit® IP67 200 Series Base Station

**Product Change Notification (PCN) Number**  
PCN 03292021-001 (mPower - Conduit)

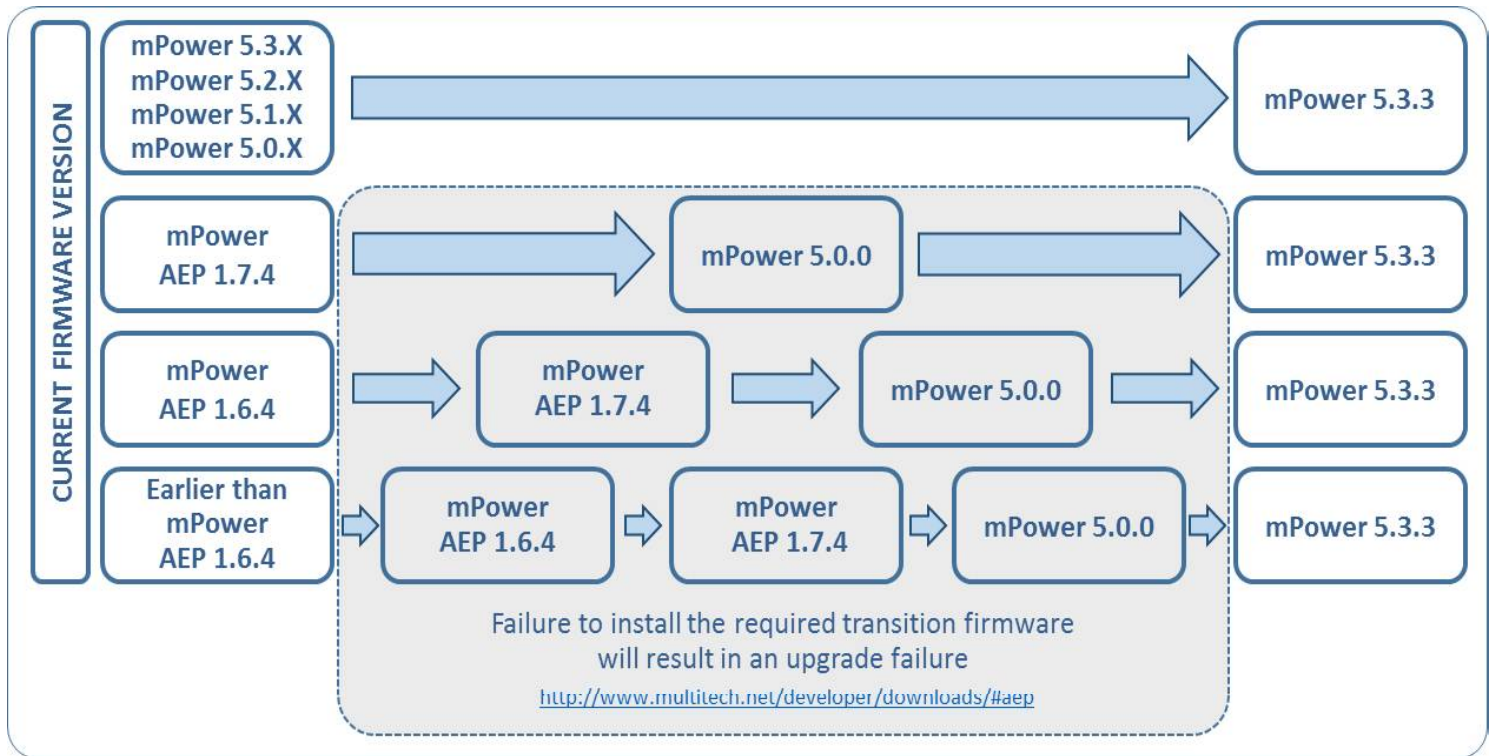
**Minimum System Requirements (mPower 5.3.3)**

To install mPower 5.3.3, the Conduit gateway must be upgraded to mPower 5.0.0 or higher. Customers that are running earlier versions of mPower should use the following upgrade process:
