# Product Change Notification / SYST-28NGOB303

ERRATA - ATmega640/1280/1281/2560/2561 Silicon Errata and Data Sheet Clarification

Description of Change: The initial release of this document

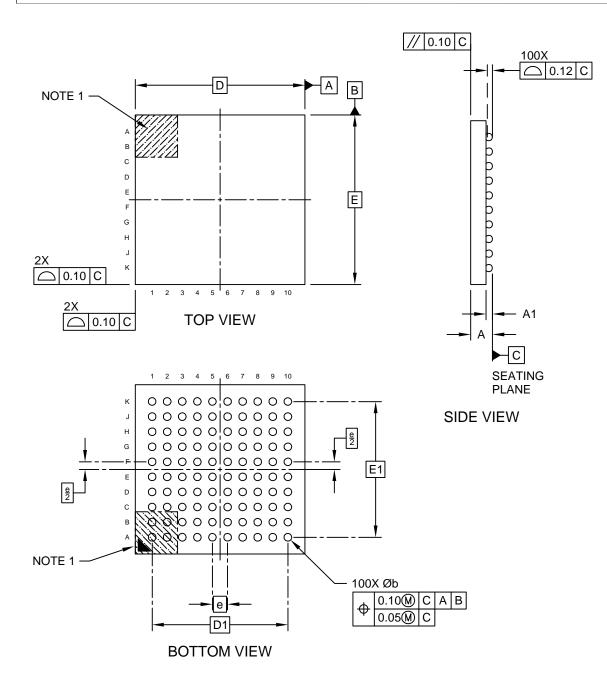
Microchip Technology Drawing C04-21111-A3B Rev A Sheet 1 of 2

### 100-Ball Ceramic Ball Grid Array Package (A3B) - 9x9 mm Body [CBGA] Atmel Legacy Global Package Code CPR

### Table 3-2. Package Reference

Package Outline Drawing MCHP reference	C04-2111
JESD97 Classification	E3

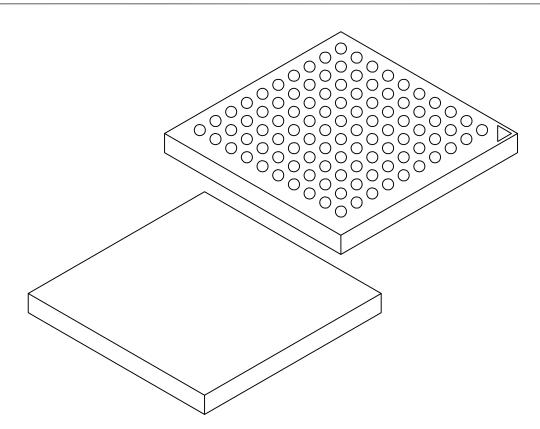
Microchip Technology Drawing C04-21111-A3B Rev A Sheet 2 of 2

## 100-Ball Ceramic Ball Grid Array Package (A3B) - 9x9 mm Body [CBGA] Atmel Legacy Global Package Code CPR

MILLIMETERS				
Dimensior	Dimension Limits		NOM	MAX	
Number of Terminals	Ν		100		
Pitch	е		0.80 BSC		
Overall Height	А	A 1.10 - 1.2			
Ball Height	A1	0.30	0.35	0.40	
Overall Length	D	9.00 BSC			
Overall Pitch	D1		7.20 BSC		
Overall Width	E	9.00 BSC			
Overall Pitch E1		7.20 BSC			
Terminal Diameter	b	0.35 0.40 0.45

1. Terminal A1 visual index feature may vary, but must be located within the hatched area.

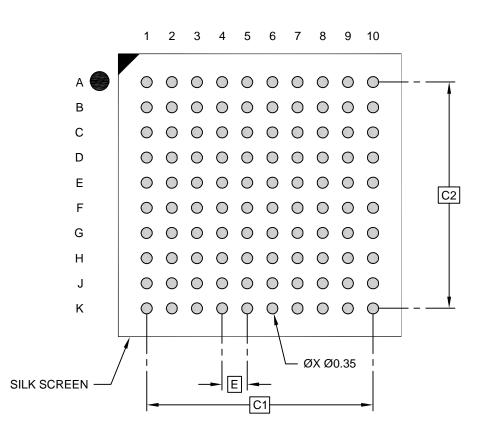
Microchip Technology Drawing C04-23111-A3B Rev A

### 100-Ball Ceramic Ball Grid Array Package (A3B) - 9x9 mm Body [CBGA] Atmel Legacy Global Package Code CPR

## RECOMMENDED LAND PATTERN

Units		MILLIMETERS		
Dimension	Dimension Limits		NOM	MAX
Contact Pitch E		0.58 BSC		
Overall Pitch C1		7.20 BSC		
Contact Pad Spacing	C2	7.20 BSC		
Contact Pad Diameter (X100)	X1			0.35

- 1. Dimensioning and tolerancing per ASME Y14.5M
  - BSC: Basic Dimension. Theoretically exact value shown without tolerances.
- 2. For best soldering results, thermal vias, if used, should be filled or tented to avoid solder loss during reflow process

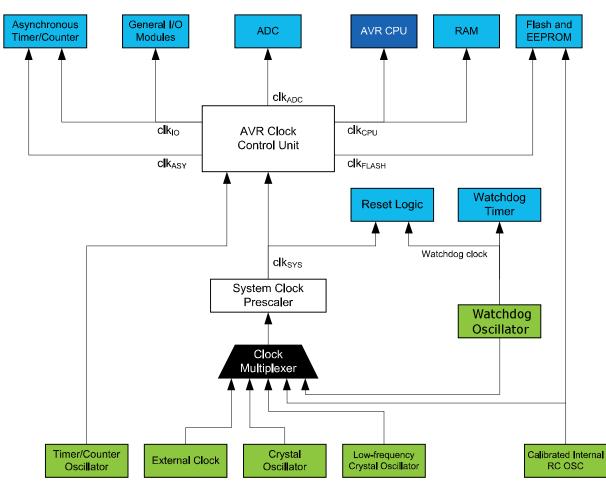
#### Figure 3-1. Clock Distribution

*Figure "Clock Distribution"* presents the different clock systems in the ATmega640/1280/1281/2560/2561 and their distribution. All of the clocks need not be active at a given time. The clocks to modules not being used can be halted using different sleep modes, as described in the "Power management and Sleep Modes" section, to reduce the power consumption.

Figure "Clock Distribution" helps select an appropriate sleep mode.

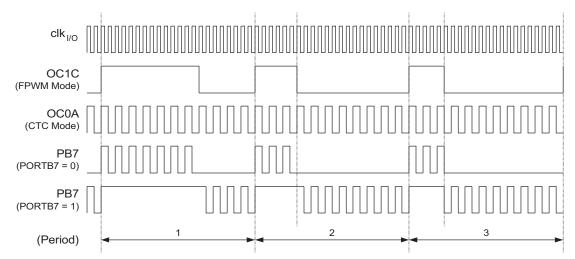
#### Figure 3-2. Output Compare Modulator, Timing Diagram

The following figure illustrates the modulator in action. In this example, the Timer/Counter1 is set to operate in fast PWM mode (non-inverted), and Timer/Counter0 uses CTC waveform mode with toggle Compare Output mode (COMnx1:0 = 1).

In this example, **Timer/Counter0** provides the carrier, while the modulating signal is generated by the Output Compare unit C of the Timer/Counter1.

The modulation has reduced the PWM signal (OC1C) resolution. The reduction factor is equal to the number of system clock cycles of one period of the carrier (OC0A). In this example, the resolution is reduced by a factor of two. The figure illustrates the reason for the reduction at the second and third periods of the PB7 output when PORTB7 equals zero. Period 2 high time is one cycle longer than period 3 high time, but the result on the PB7 output is equal in both periods.
